## Access Compliance Report Public Rights-of-Way (Curb Ramps)

Intersection ID: 18958 Main Street: GROVER\_RD Cross Street: OLD\_PINEVILLE\_RD Location: SE

ADA ID: 9BA5C1250EEB Ramp Type: Perp Initial Pass/Fail: Fail Overall Compliance: No Severity Score: 12.5

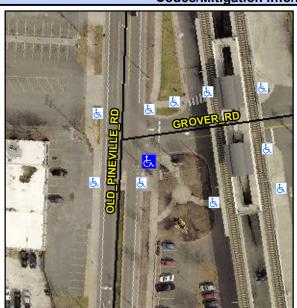
| ונ | Possible Solution | | Fleid Measurements/Component Compilance | | | | | |
|---|---|---|---|---|---|---|---|--|
| Sept of | Remove & Replace Entire Ramp. | N/A | Ramp Length (in) | 110.0 | Yes | Ramp Slope (%) | 5.7 | |
| - | | Yes | Ramp Width (in) | 48.0 | No | Ramp XSlope (%) | 5.6 | |
