Access Compliance Report Public Rights-of-Way (Curb Ramps)

Intersection ID: 13704	Main Street: CHESTERFIELD AV	Cross	Street				Location:	N
			Cross Street: THE_PLAZA					
ADA ID: 9BB109D9A393 Ramp Type: PerpDiag		Initial	nitial Pass/Fail: Fail Overall Compliance: No				o Severity Score:	33.75
Codes/Mitigation Info/Possible Solution			Field Measurements/Component Compliance					
10- Ali	Possible Solutions:		Compliance Description		Data Compliance Description		Data	
	Remove & Replace Curb Ran	np With	N/A	Ramp Length (in)	75.5	No	Ramp Slope (%)	8.6
	Two New Directional Ramps	or	No	Ramp Width (in)	43.0	No	Ramp XSlope (%)	5.5
	Equivalent.		N/A	Flare Type LT	N/A	N/A	Flare Type RT	N/A
			N/A	Flare Slope LT (%)	N/A	N/A	Flare Slope RT (%)	N/A
			N/A	Flare Traversable LT?	N/A	N/A	Flare Traversable RT?	N/A
DE Cas FI . In	and the second s		N/A	Landing Length (in)	N/A	N/A	DWS Provided?	N/A
	Surveyor Notes:		N/A	Landing Width (in)	N/A	N/A	DWS Contrast?	N/A
Mar K	N/A		N/A	Landing Slope (%)	N/A	N/A	DWS Length (in)	N/A

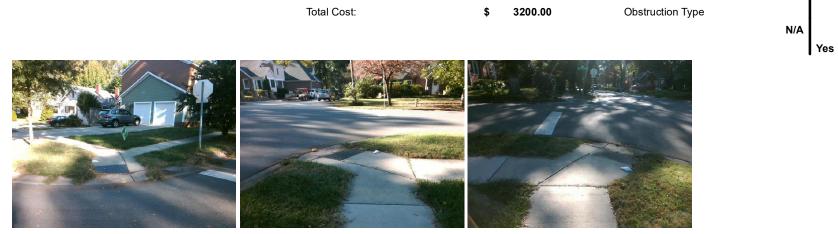
A A A A A A A A A A A A A A A A A A A	24		N/A	Landing X Slope (%)	N/A	N/A	DWS Full Width?	N/A
E AV			N/A	Landing Curb? (Y/N)	N/A	N/A	DWS Offset (in)	N/A
6			N/A	Shared Landing?	N/A			
	PROW/ADA:		N/A	Gutter Ponding?	N/A	N/A	Gutter Slope (%)	N/A
	R304.5.1, R304.2.2, R304.5.3		N/A	Gutter Lip Ht (in)	N/A	N/A	Gutter X Slope (%)	N/A
	L Marine		N/A	Painted X Walk1?	No	N/A	Painted X Walk2?	No
	let 1			X Walk 1 Direction	To SW		X Walk 2 Direction	To SE
			N/A	X Walk 1 Width (in)	N/A	N/A	X Walk 2 Width (in)	N/A
Street 1 Name CHESTERF	FIELD AV			X Walk 1 Slope (%)	0.7		X Walk 2 Slope (%)	6.7
Stop Condition-Street 2 S	StopSign			X Walk 1 X Slope (%)	6.2		X Walk 2 X Slope (%)	0.5
Street 2 Name THE	E PLAZA		N/A	Ramp inside XWalk1?	N/A	N/A	Ramp inside XWalk2?	N/A
Stop Condition-Street 1 S	StopSign			Road Slope (%)	5.3	N/A	Clear Space?	N/A
				Road X Slope (%)	4.6	N/A	Clear Space to XWalk (in)	N/A
			N/A	Any Obstructions?	N/A	N/A	Storm Grate/Utility Hazard?	N/A

Total Cost: \$	3200.00		Obstruction Type			Storm Grate/Utility Type	
					N/A			N/A
