Access Compliance Report

Public Rights-of-Way

(Curb Ramps)

| Intersection ID: 43133 | Main Street: STATESVILLE_AV | Cross Street: CARMINE_ST | Location: W |

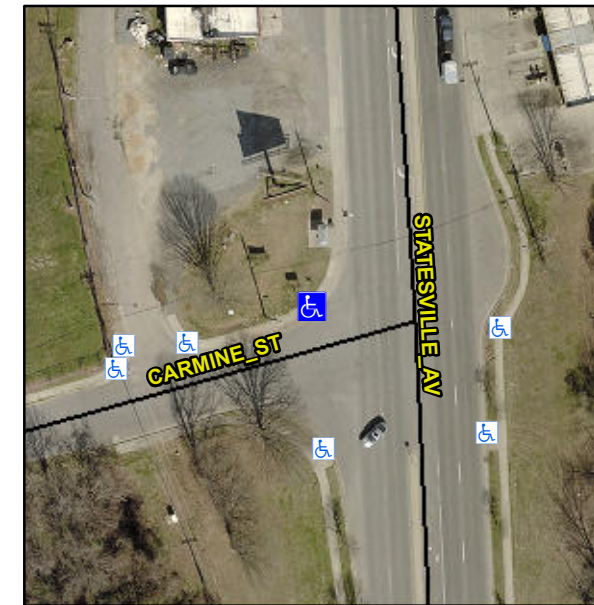
| ADA ID: 9BB469FCC7BE | Ramp Type: ParaDiag | Initial Pass/Fail: Fail | Overall Compliance: No |

| Compliance | Description | Data | Compliance | Description | Data |
|---|---|---|---|---|---|
| Yes | Ramp Slope LT (%) | 7.4 | No | Ramp Slope RT (%) | 8.7 |
| No | Ramp XSlope LT (%) | 3.6 | Yes | Ramp XSlope RT (%) | 1.7 |

Possible Solutions:

Remove & Replace Curb Ramp With Two New Directional Ramps or Equivalent.

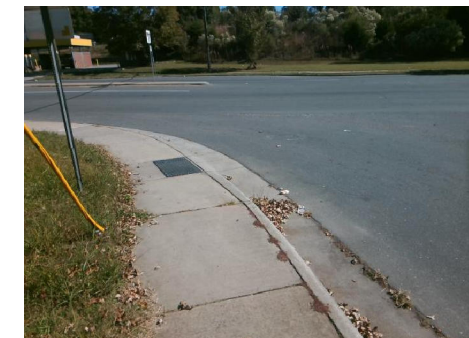
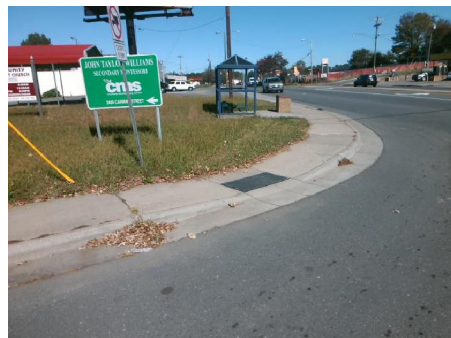
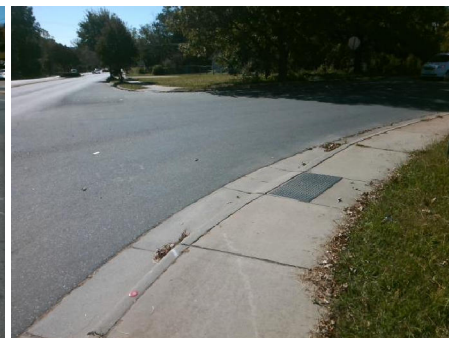
Street 1 Name CARMINE ST
 Stop Condition-Street 1 StopSign
 Street 2 Name STATESVILLE AV
 Stop Condition-Street 2 None
