Access Compliance Report

Public Rights-of-Way

(Curb Ramps)

Intersection ID: 13137	Main Street: CENTRAL_AV	Cross Street: THOMAS_AV	Location: SW
ADA ID: 9BB55AC64A6F	Ramp Type: Perp	Initial Pass/Fail: Fail	Overall Compliance: No
			Severity Score: 26.25

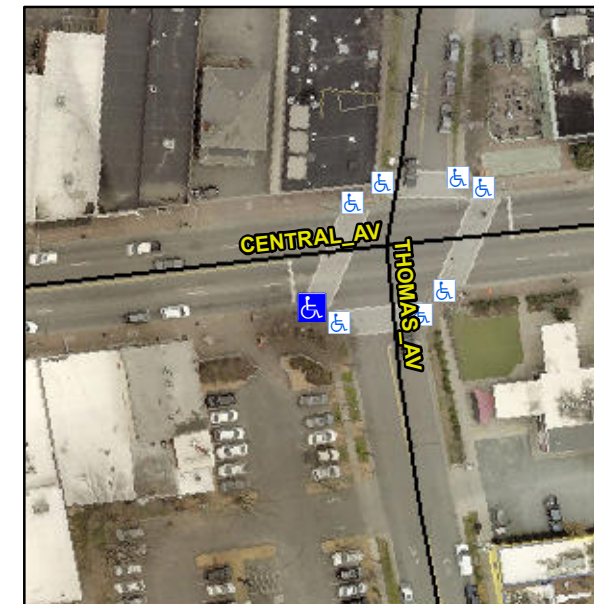
Not Found, R304.2.2, R304.5.3

Compliance	Description	Data	Compliance	Description	Data
N/A	Ramp Length (in)	70.0	No	Ramp Slope (%)	15.4
Yes	Ramp Width (in)	48.0	No	Ramp XSlope (%)	2.2
N/A	Flare Type LT	N/A	N/A	Flare Type RT	N/A
N/A	Flare Slope LT (%)	N/A	N/A	Flare Slope RT (%)	N/A
N/A	Flare Traversable LT?	N/A	N/A	Flare Traversable RT?	N/A
N/A	Landing Length (in)	N/A	N/A	DWS Provided?	N/A
N/A	Landing Width (in)	N/A	N/A	DWS Contrast?	N/A
N/A	Landing Slope (%)	N/A	N/A	DWS Length (in)	N/A
N/A	Landing X Slope (%)	N/A	N/A	DWS Full Width?	N/A
N/A	Landing Curb? (Y/N)	N/A	N/A	DWS Offset (in)	N/A
N/A	Shared Landing?	N/A			
N/A	Gutter Ponding?	N/A	N/A	Gutter Slope (%)	N/A
N/A	Gutter Lip Ht (in)	N/A	N/A	Gutter X Slope (%)	N/A
N/A	Painted X Walk1?	Yes	N/A	Painted X Walk2?	N/A
	X Walk 1 Direction	To NE		X Walk 2 Direction	N/A
N/A	X Walk 1 Width (in)	141.0	N/A	X Walk 2 Width (in)	N/A
	X Walk 1 Slope (%)	3.3		X Walk 2 Slope (%)	N/A
	X Walk 1 X Slope (%)	1.4		X Walk 2 X Slope (%)	N/A

N/A	Ramp inside XWalk1?	Yes	N/A	Ramp inside XWalk2?	N/A
	Road Slope (%)	N/A	N/A	Clear Space?	N/A
	Road X Slope (%)	N/A	N/A	Clear Space to XWalk (in)	N/A
N/A	Any Obstructions?	N/A	N/A	Storm Grate/Utility Hazard?	N/A
	Obstruction Type			Storm Grate/Utility Type	
		N/A			N/A
			Yes	Surface Condition? (G/P)	Good

Remove & Replace Entire Ramp.
