Access Compliance Report

Public Rights-of-Way (Curb Ramps)

| Intersection ID: 14493 | Main Street: CARONIA_ST | Cross Street: CLANTON_RD | Location: SW |
| ADA ID: 9BC236E71388 | Ramp Type: Directional1 | Initial Pass/Fail: Fail | Overall Compliance: No |

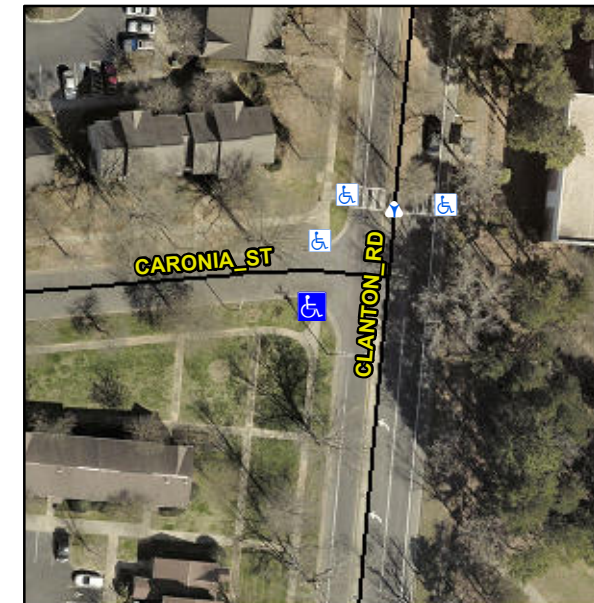
| | | Severity Score: 12.5 | |

R304.2.2

| Compliance | Description | Data | Compliance | Description | Data |
|---|---|---|---|---|---|
| No | Ramp Slope (%) | 11.6 | N/A | Grade Break XSlope (%) | 0.0 |

Remove & Replace Entire Ramp.

\$ 1600.00
