# Access Compliance Report

## Public Rights-of-Way

### (Curb Ramps)

| Intersection ID: 27452 | Main Street: BALLANTYNE COMMONS PY | Cross Street: BALLANTYNE CORPORATE PL | Location: NE |

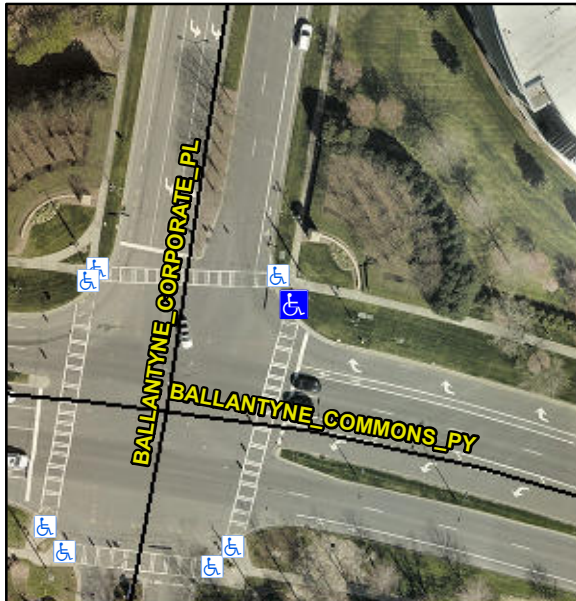
**Not Found, R304.5.3, R305.1.4**

| Compliance | Description | Data | Compliance | Description | Data |
|---|---|---|---|---|---|
| No | Landing X Slope (%) | 4.0 | No | DWS Full Width? | No |

**Remove & Replace Entire Ramp.**
