# Access Compliance Report

## Public Rights-of-Way

### (Curb Ramps)

| Intersection ID: 24194 | Main Street: SHANNOPIN_DR | Cross Street: BEVERLY_CREST_BV | Location: NE |

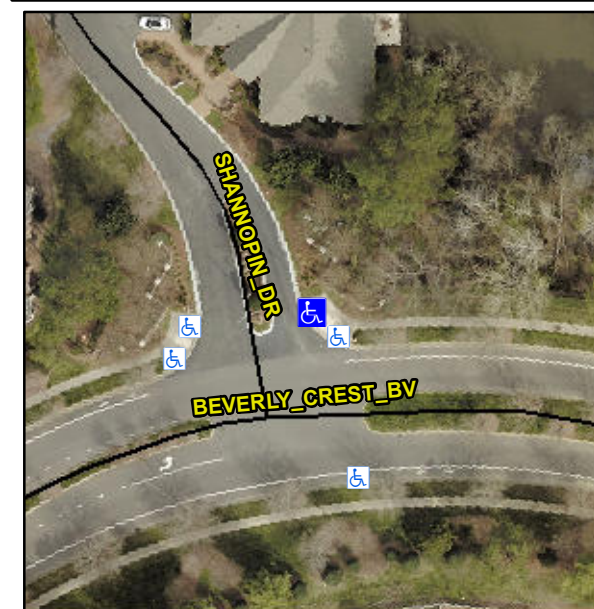
**Not Found, R304.2.2, R304.5.3**

| Compliance | Description | Data | Compliance | Description | Data |
|---|---|---|---|---|---|
| N/A | Ramp Length (in) | 108.0 | No | Ramp Slope (%) | 8.9 |
| Yes | Ramp Width (in) | 74.0 | No | Ramp XSlope (%) | 5.1 |

**Remove & Replace Entire Ramp.**

Total Cost: \$ 1850.00
