Access Compliance Report

Public Rights-of-Way

(Curb Ramps)

| Intersection ID: 50609 | Main Street: DOWNY_BIRCH_RD | Cross Street: PADDLE_OAK_RD | Location: NE |

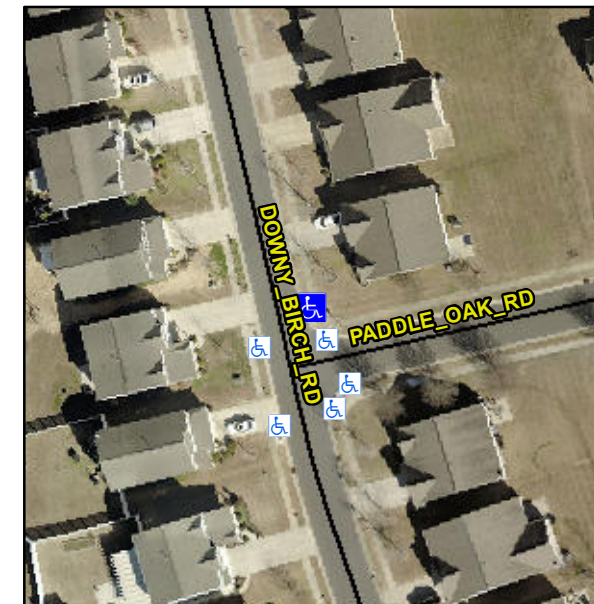
Not Found, R304.2.2-Perp, R304.3.2-Para, R304.5.3, R305.2

| Compliance | Description | Data | Compliance | Description | Data |
|---|---|---|---|---|---|
| No | Landing Slope (%) | 4.1 | Yes | DWS Length (in) | 24.5 |
| No | Landing X Slope (%) | 2.2 | Yes | DWS Full Width? | Yes |
| N/A | Landing Curb? (Y/N) | No | No | DWS Offset (in) | 5.8 |

Possible Solutions:

Remove & Replace Entire Ramp.
