# Access Compliance Report

## Public Rights-of-Way

### (Curb Ramps)

Intersection ID: 3098	Main Street: STEWART_SPRING_LN	Cross Street: WALDEN_RIDGE_DR	Location: S
ADA ID: 9BF070C3C2AE	Ramp Type: BlendTrans2	Initial Pass/Fail: Fail	Overall Compliance: No
Severity Score: 1.25			
Codes/Mitigation Info/Possible Solution		Field Measurements/Component Compliance

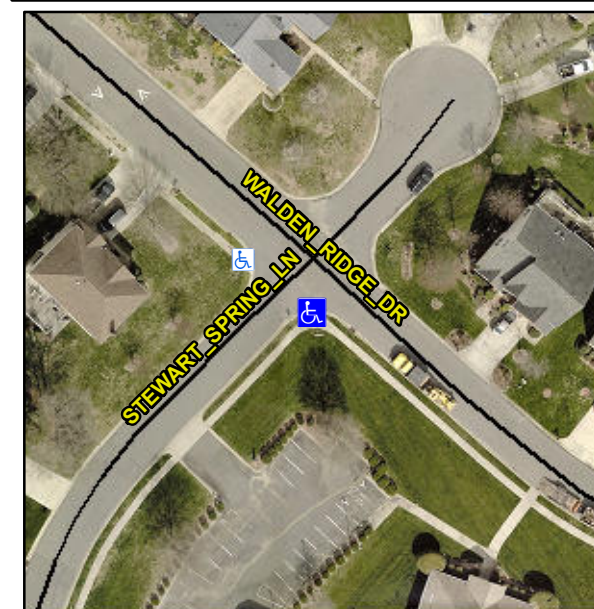
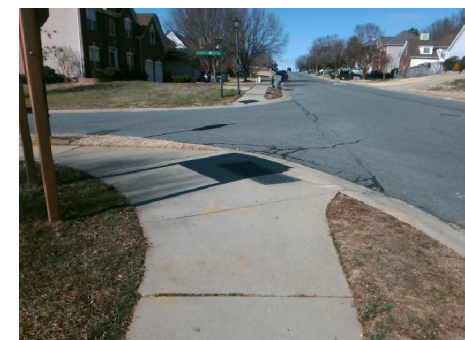
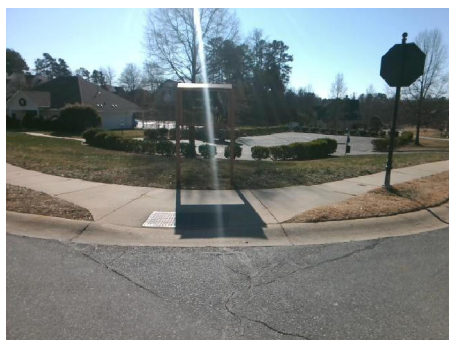
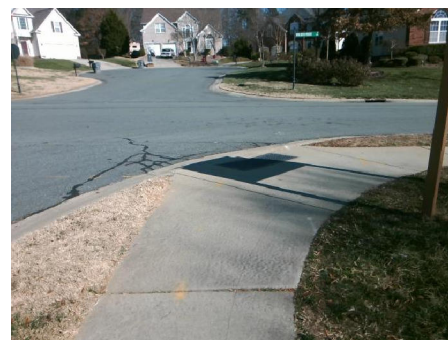
**Not Found, R304.5.3**

Compliance	Description	Data	Compliance	Description	Data
N/A	Ramp Length (in)	94.0	Yes	BlendTrans Slope (%)	2.5
Yes	Ramp Width (in)	48.0	No	BlendTrans XSlope (%)	2.6
N/A	Flare Type LT	N/A	N/A	Flare Type RT	N/A
N/A	Flare Slope LT (%)	N/A	N/A	Flare Slope RT (%)	N/A
N/A	Flare Traversable LT?	N/A	N/A	Flare Traversable RT?	N/A
N/A	Landing Length (in)	N/A	N/A	DWS Provided?	N/A
N/A	Landing Width (in)	N/A	N/A	DWS Contrast?	N/A
N/A	Landing Slope (%)	N/A	N/A	DWS Length (in)	N/A
N/A	Landing X Slope (%)	N/A	N/A	DWS Full Width?	N/A
N/A	Landing Curb? (Y/N)	N/A	N/A	DWS Offset (in)	N/A
N/A	Shared Landing?	N/A			
N/A	Gutter Ponding?	N/A	N/A	Gutter Slope (%)	N/A
N/A	Gutter Lip Ht (in)	N/A	N/A	Gutter X Slope (%)	N/A
N/A	Painted X Walk1?	No	N/A	Painted X Walk2?	N/A
	X Walk 1 Direction	To NW		X Walk 2 Direction	N/A
	X Walk 1 Width (in)	N/A		X Walk 2 Width (in)	N/A
	X Walk 1 Slope (%)	3.4		X Walk 2 Slope (%)	N/A
	X Walk 1 X Slope (%)	4.1		X Walk 2 X Slope (%)	N/A

N/A	Ramp inside XWalk1?	N/A	N/A	Ramp inside XWalk2?	N/A
	Road Slope (%)	4.1		Clear Space?	N/A
	Road X Slope (%)	3.4	N/A	Clear Space to XWalk (in)	N/A
N/A	Any Obstructions?	N/A	N/A	Storm Grate/Utility Hazard?	N/A
	Obstruction Type			Storm Grate/Utility Type	
		N/A			N/A
			Yes	Surface Condition? (G/P)	Good
			No	Curb Slope (%)	10.2

**Remove & Replace Curb Ramp With Two New Directional Ramps or Equivalent.**
