# Access Compliance Report

## Public Rights-of-Way

### (Curb Ramps)

| ADA ID: 9C05CB74B5B9 | Ramp Type: Perp | Initial Pass/Fail: Fail | Overall Compliance: No |

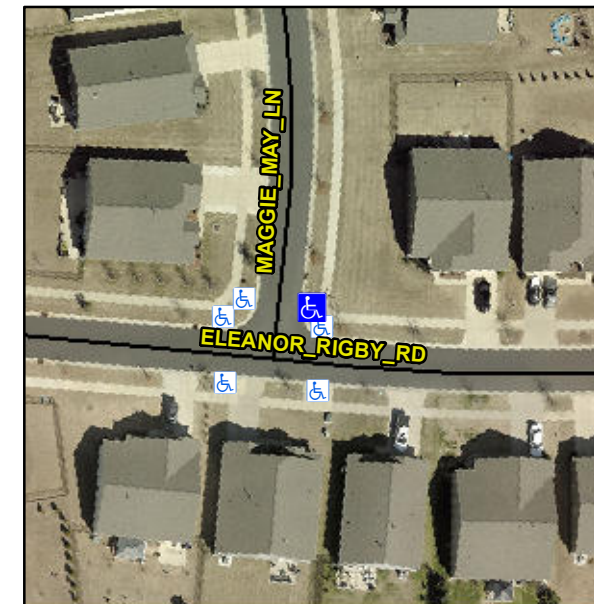
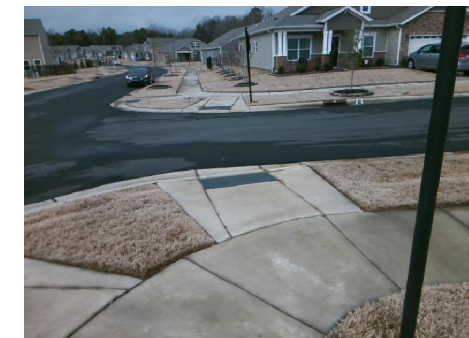
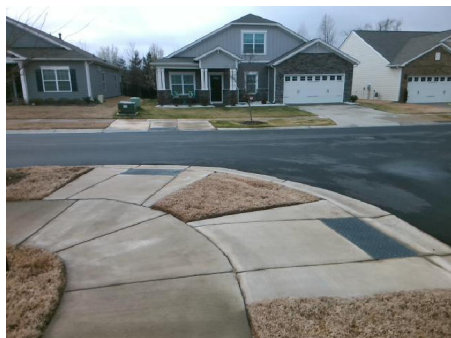
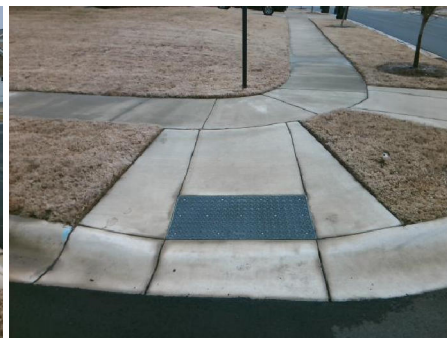
| | | Severity Score: 10 | |

**Not Found, R304.5.1, R304.5.3**

| Compliance | Description | Data | Compliance | Description | Data |
|---|---|---|---|---|---|
| N/A | Ramp Length (in) | 88.0 | Yes | Ramp Slope (%) | 7.1 |
| No | Ramp Width (in) | 46.0 | No | Ramp XSlope (%) | 2.8 |

**Remove & Replace Entire Ramp.**

Total Cost: \$ 1850.00
