# Access Compliance Report

## Public Rights-of-Way

### (Curb Ramps)

Intersection ID: 31794	Main Street: ROMARE_BEARDEN_DR	Cross Street: SPRING_FOREST_DR	Location: NE
ADA ID: 9C210862ECC1	Ramp Type: Perp	Initial Pass/Fail: Fail	Overall Compliance: No
Severity Score: 22.5			
Codes/Mitigation Info/Possible Solution		Field Measurements/Component Compliance

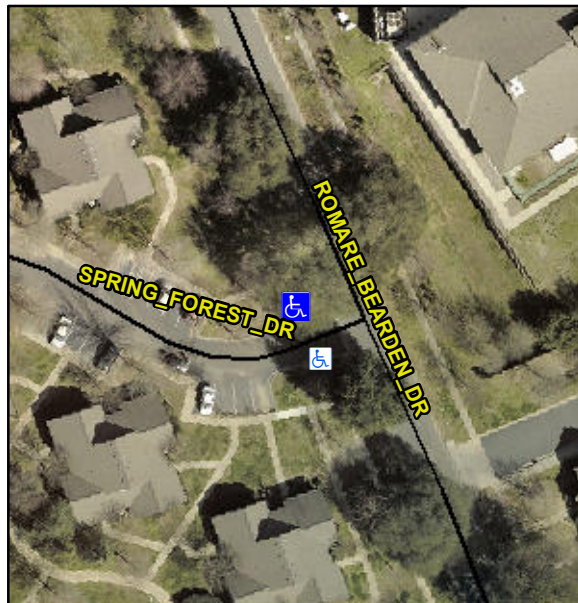
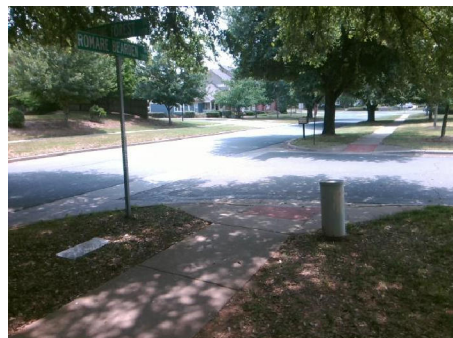
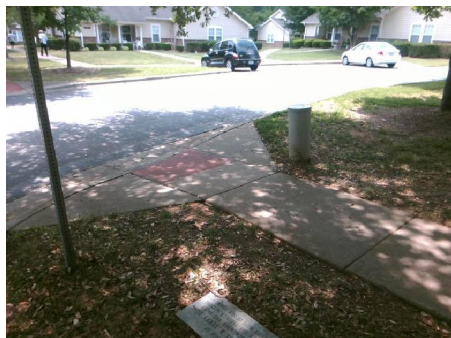
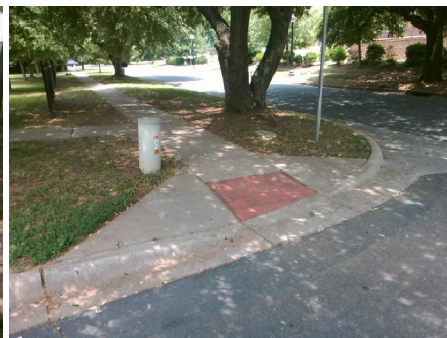
**Not Found, R304.5.1, R304.2.2, R304.5.3**

Compliance	Description	Data	Compliance	Description	Data
N/A	Ramp Length (in)	62.0	No	Ramp Slope (%)	10.1
No	Ramp Width (in)	47.0	No	Ramp XSlope (%)	4.9
N/A	Flare Type LT	N/A	N/A	Flare Type RT	N/A
N/A	Flare Slope LT (%)	N/A	N/A	Flare Slope RT (%)	N/A
N/A	Flare Traversable LT?	N/A	N/A	Flare Traversable RT?	N/A
N/A	Landing Length (in)	N/A	N/A	DWS Provided?	N/A
N/A	Landing Width (in)	N/A	N/A	DWS Contrast?	N/A
N/A	Landing Slope (%)	N/A	N/A	DWS Length (in)	N/A
N/A	Landing X Slope (%)	N/A	N/A	DWS Full Width?	N/A
N/A	Landing Curb? (Y/N)	N/A	N/A	DWS Offset (in)	N/A
N/A	Shared Landing?	N/A			
N/A	Gutter Ponding?	N/A	N/A	Gutter Slope (%)	N/A
N/A	Gutter Lip Ht (in)	N/A	N/A	Gutter X Slope (%)	N/A
N/A	Painted X Walk1?	No	N/A	Painted X Walk2?	N/A
	X Walk 1 Direction	To S		X Walk 2 Direction	N/A
N/A	X Walk 1 Width (in)	N/A	N/A	X Walk 2 Width (in)	N/A
	X Walk 1 Slope (%)	3.1		X Walk 2 Slope (%)	N/A
	X Walk 1 X Slope (%)	3.2		X Walk 2 X Slope (%)	N/A

N/A	Ramp inside XWalk1?	N/A	N/A	Ramp inside XWalk2?	N/A
	Road Slope (%)	N/A	N/A	Clear Space?	N/A
	Road X Slope (%)	N/A	N/A	Clear Space to XWalk (in)	N/A
N/A	Any Obstructions?	N/A	N/A	Storm Grate/Utility Hazard?	N/A
	Obstruction Type			Storm Grate/Utility Type	
		N/A			N/A
			Yes	Surface Condition? (G/P)	Good

**Remove & Replace Entire Ramp.**

Total Cost: \$ 1850.00
