# Access Compliance Report

## Public Rights-of-Way

### (Curb Ramps)

Intersection ID: 23574	Main Street: CARMEL_RD	Cross Street: QUAIL_HOLLOW_RD	Location: SW
ADA ID: 9C42201BA204	Ramp Type: Perp	Initial Pass/Fail: Fail	Overall Compliance: No
		Severity Score: 8.75

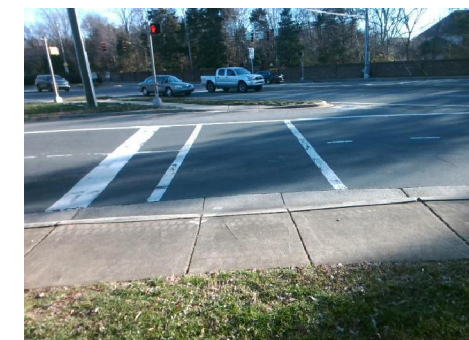
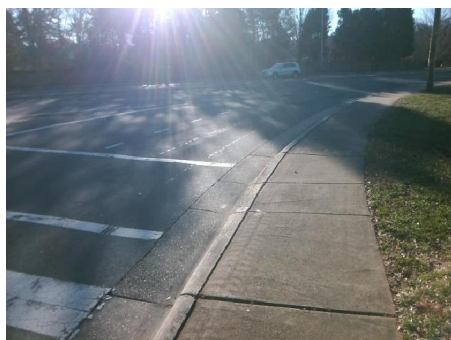
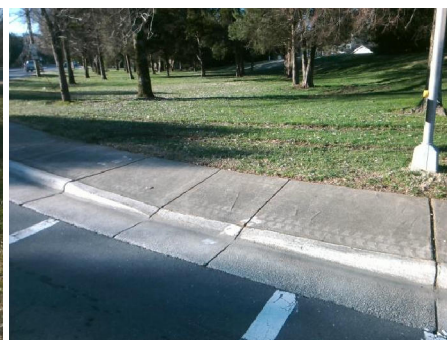
**Not Found, R304.5.1**

Compliance	Description	Data	Compliance	Description	Data
N/A	Ramp Length (in)	59.0	Yes	Ramp Slope (%)	6.8
No	Ramp Width (in)	45.5	Yes	Ramp XSlope (%)	1.1
N/A	Flare Type LT	N/A	N/A	Flare Type RT	N/A
N/A	Flare Slope LT (%)	N/A	N/A	Flare Slope RT (%)	N/A
N/A	Flare Traversable LT?	N/A	N/A	Flare Traversable RT?	N/A
N/A	Landing Length (in)	N/A	N/A	DWS Provided?	N/A
N/A	Landing Width (in)	N/A	N/A	DWS Contrast?	N/A
N/A	Landing Slope (%)	N/A	N/A	DWS Length (in)	N/A
N/A	Landing X Slope (%)	N/A	N/A	DWS Full Width?	N/A
N/A	Landing Curb? (Y/N)	N/A	N/A	DWS Offset (in)	N/A
N/A	Shared Landing?	N/A			
N/A	Gutter Ponding?	N/A	N/A	Gutter Slope (%)	N/A
N/A	Gutter Lip Ht (in)	N/A	N/A	Gutter X Slope (%)	N/A
N/A	Painted X Walk1?	Yes	N/A	Painted X Walk2?	N/A
	X Walk 1 Direction	To NE		X Walk 2 Direction	N/A
N/A	X Walk 1 Width (in)	110.0	N/A	X Walk 2 Width (in)	N/A
	X Walk 1 Slope (%)	0.4		X Walk 2 Slope (%)	N/A
	X Walk 1 X Slope (%)	0.1		X Walk 2 X Slope (%)	N/A

N/A	Ramp inside XWalk1?	Yes	N/A	Ramp inside XWalk2?	N/A
	Road Slope (%)	N/A	N/A	Clear Space?	N/A
	Road X Slope (%)	N/A	N/A	Clear Space to XWalk (in)	N/A
N/A	Any Obstructions?	N/A	N/A	Storm Grate/Utility Hazard?	N/A
	Obstruction Type			Storm Grate/Utility Type	
		N/A			N/A
			Yes	Surface Condition? (G/P)	Good

**Remove & Replace Entire Ramp.**
