# Access Compliance Report

## Public Rights-of-Way

### (Curb Ramps)

Intersection ID: N/A	Main Street: STATESVILLE_RD	Cross Street: N/A	Location: SW
ADA ID: 9C4F782964BC	Ramp Type: Directional1	Initial Pass/Fail: Fail	Overall Compliance: No
Codes/Mitigation Info/Possible Solution		Field Measurements/Component Compliance	
Severity Score: 1.25

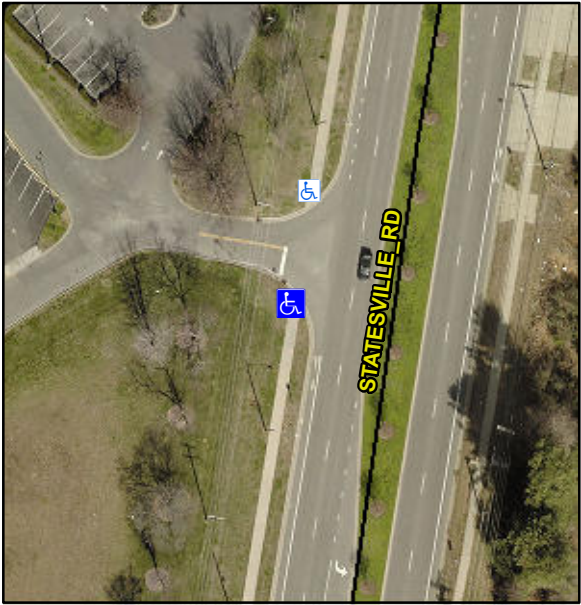
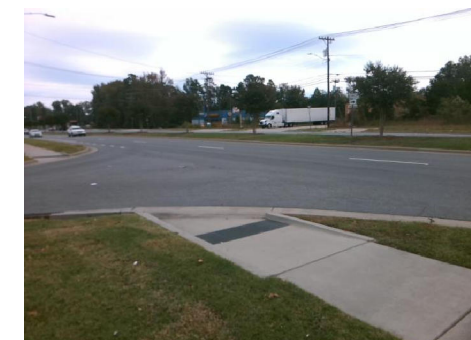
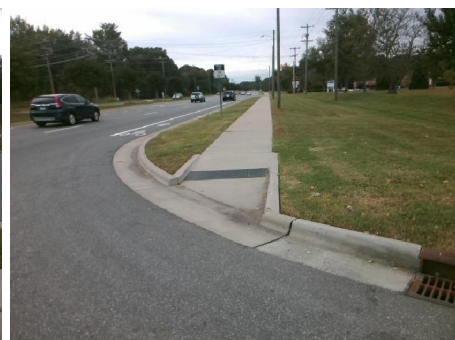
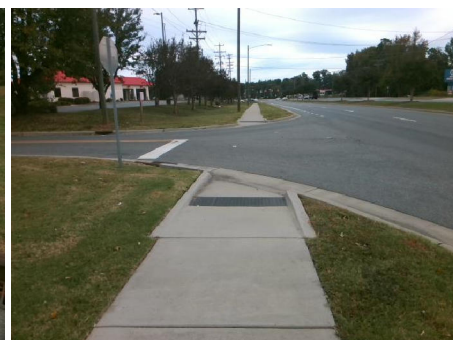
Possible Solutions:	Compliance	Description	Data	Compliance	Description	Data
	Remove & Replace Entire Ramp.	N/A	Ramp Length (in)	88.0	N/A	Grade Break?	N/A
		Yes	Ramp Width (in)	65.0	N/A	Grade Break Slope (%)	0.0
		Yes	Ramp Slope (%)	4.2	N/A	Grade Break XSlope (%)	0.0
		No	Ramp XSlope (%)	2.8			
		N/A	Flare Type LT	N/A	N/A	Flare Type RT	N/A
		N/A	Flare Slope LT (%)	N/A	N/A	Flare Slope RT (%)	0.0
		N/A	Flare Traversable LT?	N/A	N/A	Flare Traversable RT?	N/A
		N/A	Landing Length (in)	0.0	N/A	DWS Provided?	N/A
		N/A	Landing Width (in)	0.0	N/A	DWS Contrast?	N/A
		N/A	Landing Slope (%)	0.0	N/A	DWS Length (in)	N/A
		N/A	Landing X Slope (%)	0.0	N/A	DWS Full Width?	N/A
		N/A	Landing Curb? (Y/N)	N/A	N/A	DWS Offset LT (in)	N/A
		N/A	Shared Landing?	N/A	N/A	DWS Offset RT (in)	N/A
		N/A	Gutter Ponding?	0.0	N/A	Gutter Slope (%)	N/A
		N/A	Gutter Lip Ht (in)	0.0	N/A	Gutter X Slope (%)	N/A
		N/A	Painted X Walk1?	No		Road Slope (%)	0.2

X Walk 1 Direction	To NW		Road X Slope (%)	0.4
			X Walk 1 Width (in)	N/A		Clear Space?	N/A
			X Walk 1 Slope (%)	0.2	N/A	Clear Space to XWalk (in)	N/A
			X Walk 1 X Slope (%)	0.4	N/A	Storm Grate/Utility Hazard?	N/A
<p>Surveyor Notes:</p> <p>N/A</p> <p>PROW/ADA:</p> <p>R304.5.3</p>		N/A	Ramp inside XWalk1?	N/A		Storm Grate/Utility Type	
		N/A	Any Obstructions?	N/A			N/A
Total Cost:			Obstruction Type		Yes	Surface Condition? (G/P)	Good
					N/A	Curb Slope (%)	2.4
