# Access Compliance Report

## Public Rights-of-Way

Intersection ID: 18124	Main Street: S_SHARON_AMITY_RD	Cross Street: WOODLARK_LN	Location: NW
ADA ID: 9C5BD4D14E2F	Ramp Type: PerpDiag	Initial Pass/Fail: Fail	Overall Compliance: No
Severity Score: 10			
Codes/Mitigation Info/Possible Solution		Field Measurements/Component Compliance

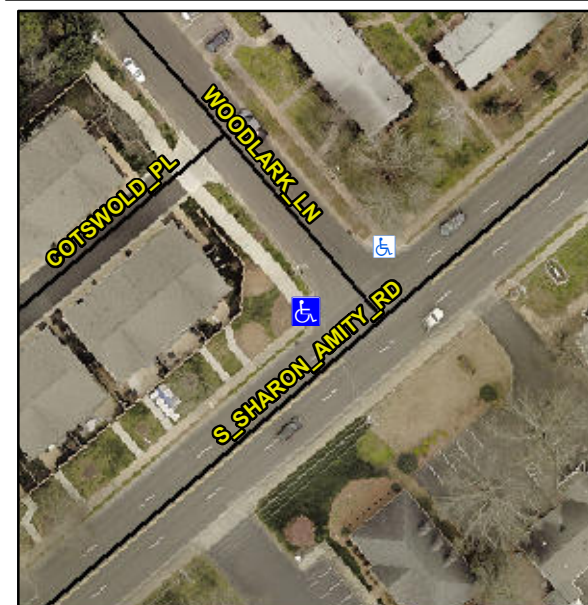
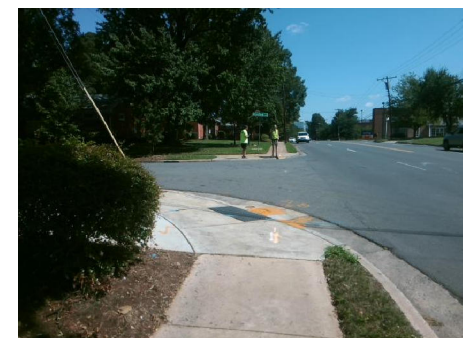
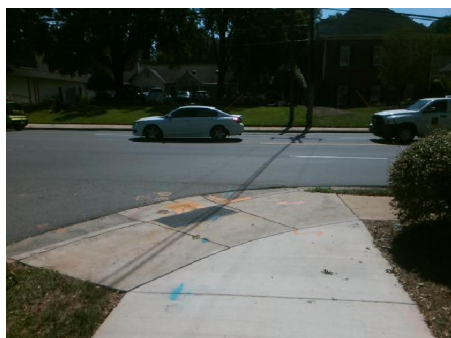
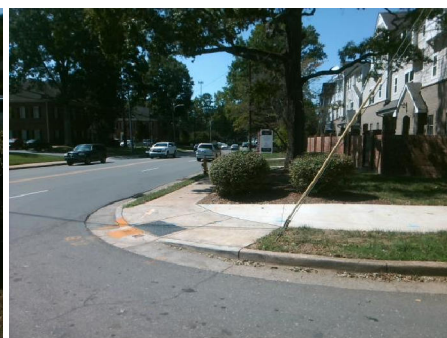
**Not Found, R304.5.1, R304.5.3**

Compliance	Description	Data	Compliance	Description	Data
N/A	Ramp Length (in)	72.0	Yes	Ramp Slope (%)	7.8
No	Ramp Width (in)	44.0	No	Ramp XSlope (%)	4.9
N/A	Flare Type LT	N/A	N/A	Flare Type RT	N/A
N/A	Flare Slope LT (%)	N/A	N/A	Flare Slope RT (%)	N/A
N/A	Flare Traversable LT?	N/A	N/A	Flare Traversable RT?	N/A
N/A	Landing Length (in)	N/A	N/A	DWS Provided?	N/A
N/A	Landing Width (in)	N/A	N/A	DWS Contrast?	N/A
N/A	Landing Slope (%)	N/A	N/A	DWS Length (in)	N/A
N/A	Landing X Slope (%)	N/A	N/A	DWS Full Width?	N/A
N/A	Landing Curb? (Y/N)	N/A	N/A	DWS Offset (in)	N/A
N/A	Shared Landing?	N/A			
N/A	Gutter Ponding?	N/A	N/A	Gutter Slope (%)	N/A
N/A	Gutter Lip Ht (in)	N/A	N/A	Gutter X Slope (%)	N/A
N/A	Painted X Walk1?	No	N/A	Painted X Walk2?	No
	X Walk 1 Direction	To SE		X Walk 2 Direction	To NE
N/A	X Walk 1 Width (in)	N/A	N/A	X Walk 2 Width (in)	N/A
	X Walk 1 Slope (%)	1.1		X Walk 2 Slope (%)	4.0
	X Walk 1 X Slope (%)	4.7		X Walk 2 X Slope (%)	0.6

N/A	Ramp inside XWalk1?	N/A	N/A	Ramp inside XWalk2?	N/A
	Road Slope (%)	2.4	N/A	Clear Space?	N/A
	Road X Slope (%)	2.8	N/A	Clear Space to XWalk (in)	N/A
N/A	Any Obstructions?	N/A	N/A	Storm Grate/Utility Hazard?	N/A
	Obstruction Type			Storm Grate/Utility Type	
		N/A			N/A
			Yes	Surface Condition? (G/P)	Good

**Remove & Replace Curb Ramp With Two New Directional Ramps or Equivalent.**
