## **Access Compliance Report Public Rights-of-Way** (Curb Ramps)

Intersection ID: 10597 Main Street: BELLE PLAINE DR Cross Street: BRIARGROVE DR Location: SW **Overall Compliance: No Severity Score:** 0 ADA ID: 9C635D6A67DD Ramp Type: Directional1 Initial Pass/Fail: Pass

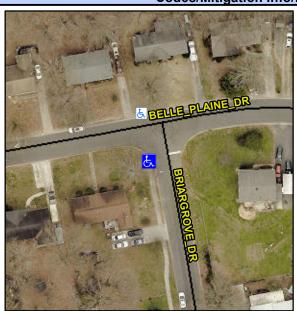
Compliance Description Possible Solutions: N/A Remove & Replace Entire Ramp. Yes Yes Yes N/A N/A Surveyor Notes: N/A N/A Yes Yes Yes Yes PROW/ADA: N/A Not Found, R304.5.3, R305.2 N/A Yes Yes N/A
