# Access Compliance Report

## Public Rights-of-Way

### (Curb Ramps)

Intersection ID: 27777	Main Street: BRIARWICK_LN	Cross Street: MOSS_MILL_LN	Location: NW
ADA ID: 9C6EC0A4F8EA	Ramp Type: PerpDiag	Initial Pass/Fail: Fail	Overall Compliance: No
Severity Score: 25			
Codes/Mitigation Info/Possible Solution		Field Measurements/Component Compliance

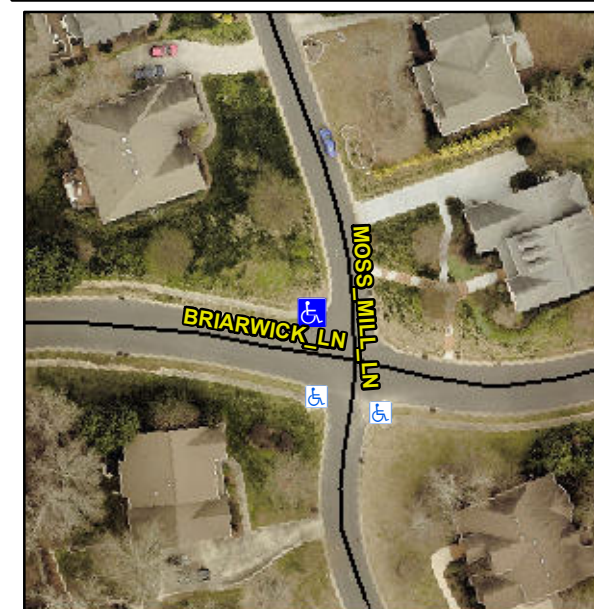
Compliance	Description	Data	Compliance	Description	Data
N/A	Ramp Length (in)	96.0	Yes	Ramp Slope (%)	5.4
Yes	Ramp Width (in)	48.0	No	Ramp XSlope (%)	11.2
N/A	Flare Type LT	N/A	N/A	Flare Type RT	N/A
N/A	Flare Slope LT (%)	N/A	N/A	Flare Slope RT (%)	N/A
N/A	Flare Traversable LT?	N/A	N/A	Flare Traversable RT?	N/A
N/A	Landing Length (in)	N/A	N/A	DWS Provided?	N/A
N/A	Landing Width (in)	N/A	N/A	DWS Contrast?	N/A
N/A	Landing Slope (%)	N/A	N/A	DWS Length (in)	N/A
N/A	Landing X Slope (%)	N/A	N/A	DWS Full Width?	N/A
N/A	Landing Curb? (Y/N)	N/A	N/A	DWS Offset (in)	N/A
N/A	Shared Landing?	N/A			
N/A	Gutter Ponding?	N/A	N/A	Gutter Slope (%)	N/A
N/A	Gutter Lip Ht (in)	N/A	N/A	Gutter X Slope (%)	N/A
N/A	Painted X Walk1?	No	N/A	Painted X Walk2?	No
	X Walk 1 Direction	To SW		X Walk 2 Direction	To SE
N/A	X Walk 1 Width (in)	N/A	N/A	X Walk 2 Width (in)	N/A
	X Walk 1 Slope (%)	0.5		X Walk 2 Slope (%)	6.9
	X Walk 1 X Slope (%)	6.5		X Walk 2 X Slope (%)	2.7

N/A	Ramp inside XWalk1?	N/A	N/A	Ramp inside XWalk2?	N/A
	Road Slope (%)	6.9	N/A	Clear Space?	N/A
	Road X Slope (%)	5.1	N/A	Clear Space to XWalk (in)	N/A
N/A	Any Obstructions?	N/A	N/A	Storm Grate/Utility Hazard?	N/A
	Obstruction Type			Storm Grate/Utility Type	
		N/A			N/A
		Yes		Surface Condition? (G/P)	Good

**Remove & Replace Curb Ramp With Two New Directional Ramps or Equivalent.**

**Not Found, R304.5.3**
