## **Access Compliance Report Public Rights-of-Way** (Curb Ramps)

Intersection ID: 11467 Main Street: WALNUT AV Cross Street: LELA\_AV Location: N **Overall Compliance: No ADA ID: 9C849C6D6BEB** Ramp Type: BlendTrans2 Initial Pass/Fail: Fail **Severity Score:** 10

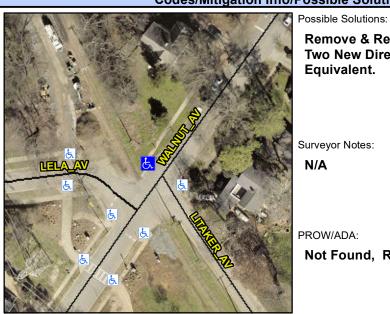
Surveyor Notes:			
N/A			
PROW/ADA:			
Not Found,	R304.5.1,	R304.5.3	1
Total Cost:		\$	3200.00

Field Measurements/Component Compliance								
Comp	liance Description	Data	Comp	liance Description	Data			
N/A	Ramp Length (in)	79.0	Yes	BlendTrans Slope (%)	1.2			
No	Ramp Width (in)	47.0	No BlendTrans XSlope (%)		2.8			
N/A	Flare Type LT	N/A	N/A Flare Type RT		N/A			
N/A	Flare Slope LT (%)	N/A	N/A	Flare Slope RT (%)	N/A			
N/A	Flare Traversable LT?	N/A	N/A	Flare Traversable RT?	N/A			
N/A	Landing Length (in)	N/A	N/A	DWS Provided?	N/A			
N/A	Landing Width (in)	N/A	N/A	DWS Contrast?	N/A			
N/A	Landing Slope (%)	N/A	N/A	DWS Length (in)	N/A			
N/A	Landing X Slope (%)	N/A	N/A	DWS Full Width?	N/A			
N/A	Landing Curb? (Y/N)	N/A	N/A	DWS Offset (in)	N/A			
N/A	Shared Landing?	N/A						
N/A	Gutter Ponding?	N/A	N/A	Gutter Slope (%)	N/A			
N/A	Gutter Lip Ht (in)	0.5	N/A	Gutter X Slope (%)	N/A			
N/A	Painted X Walk1?	No	N/A	Painted X Walk2?	N/A			
	X Walk 1 Direction	To SE		X Walk 2 Direction	N/A			
	X Walk 1 Width (in)	N/A		X Walk 2 Width (in)	N/A

X Walk 1 Slope (%)	7.4		X Walk 2 Slope (%)	N/A			
	X Walk 1 X Slope (%)	1.6		X Walk 2 X Slope (%)	N/A			
N/A	Ramp inside XWalk1?	N/A	N/A	Ramp inside XWalk2?	N/A			
	Road Slope (%)	1.6		Clear Space?	N/A			
	Road X Slope (%)	7.4	N/A	Clear Space to XWalk (in)	N/A			
N/A	Any Obstructions?	N/A	N/A	Storm Grate/Utility Hazard?	N/A			
	Obstruction Type			Storm Grate/Utility Type				
		N/A			N/A			
			Yes	Surface Condition? (G/P)	Good			
3	- T		No	Curb Slope (%)	14.7

**WALNUT AV** Street 1 Name Stop Condition-Street 1 StopSign Street 2 Name N/A Stop Condition-Street 2 N/A Remove & Replace Curb Ramp With Two New Directional Ramps or Equivalent.
