Intersection ID: 27927	Main Street: FAIR_ISLE_DR	Cross Street: INNES_CT	Location:	SW
ADA ID: 9C8F8D87858F	Ramp Type: PerpDiag	Initial Pass/Fail: Fail	Overall Compliance: No	Severity Score: 12.5

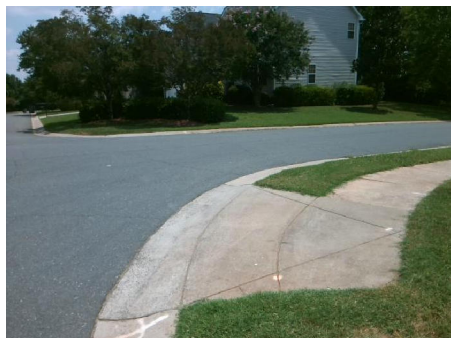
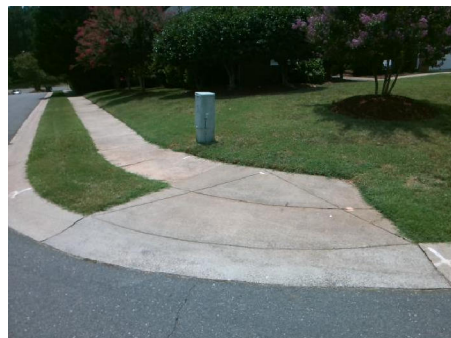
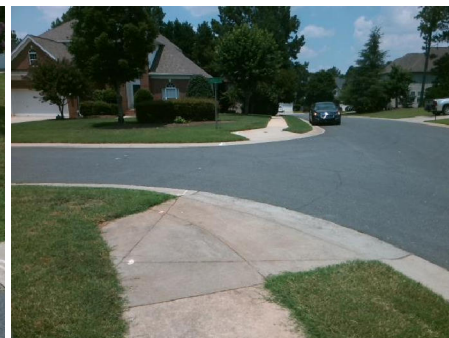
Compliance	Description	Data	Compliance	Description	Data
N/A	Ramp Length (in)	41.0	Yes	Ramp Slope (%)	5.5
Yes	Ramp Width (in)	141.0	No	Ramp XSlope (%)	5.4
N/A	Flare Type LT	N/A	N/A	Flare Type RT	N/A
N/A	Flare Slope LT (%)	N/A	N/A	Flare Slope RT (%)	N/A
N/A	Flare Traversable LT?	N/A	N/A	Flare Traversable RT?	N/A
N/A	Landing Length (in)	N/A	N/A	DWS Provided?	N/A
N/A	Landing Width (in)	N/A	N/A	DWS Contrast?	N/A
N/A	Landing Slope (%)	N/A	N/A	DWS Length (in)	N/A
N/A	Landing X Slope (%)	N/A	N/A	DWS Full Width?	N/A
N/A	Landing Curb? (Y/N)	N/A	N/A	DWS Offset (in)	N/A
N/A	Shared Landing?	N/A			
N/A	Gutter Ponding?	N/A	N/A	Gutter Slope (%)	N/A
N/A	Gutter Lip Ht (in)	N/A	N/A	Gutter X Slope (%)	N/A
N/A	Painted X Walk1?	No	N/A	Painted X Walk2?	No
	X Walk 1 Direction	To E		X Walk 2 Direction	To N
N/A	X Walk 1 Width (in)	N/A	N/A	X Walk 2 Width (in)	N/A
	X Walk 1 Slope (%)	2.3		X Walk 2 Slope (%)	0.5
	X Walk 1 X Slope (%)	2.0		X Walk 2 X Slope (%)	2.1

N/A	Ramp inside XWalk1?	N/A	N/A	Ramp inside XWalk2?	N/A
	Road Slope (%)	0.6	N/A	Clear Space?	N/A
	Road X Slope (%)	4.1	N/A	Clear Space to XWalk (in)	N/A
N/A	Any Obstructions?	N/A	N/A	Storm Grate/Utility Hazard?	N/A
	Obstruction Type			Storm Grate/Utility Type	
		N/A			N/A
			Yes	Surface Condition? (G/P)	Good

Remove & Replace Curb Ramp With Two New Directional Ramps or Equivalent.

R304.5.3

\$ 3200.00
