Intersection ID: 17531	Main Street: HILLSIDE_AV	Cross Street: WESTFIELD_RD	Location:	NW
ADA ID: 9C93F3D50331	Ramp Type: PerpDiag	Initial Pass/Fail: Fail	Overall Compliance: No	Severity Score: 12.5

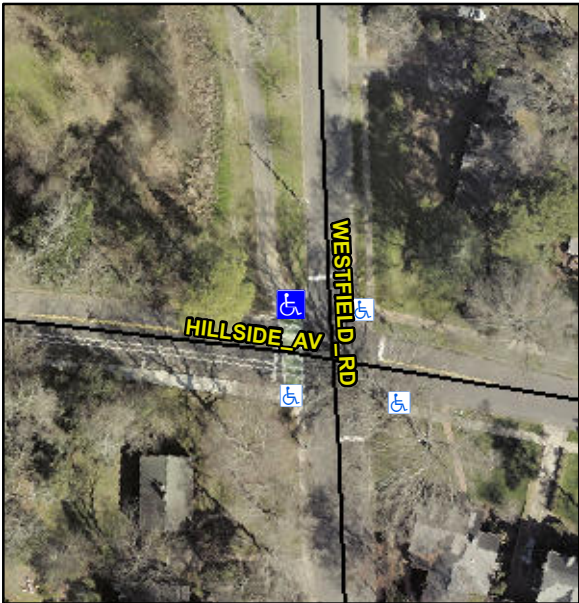
Possible Solutions:		Compliance	Description	Data	Compliance	Description	Data
	<b>Remove &amp; Replace Curb Ramp With Two New Directional Ramps or Equivalent.</b>		N/A	Ramp Length (in)	70.0	No	Ramp Slope (%)	9.2
			Yes	Ramp Width (in)	48.0	Yes	Ramp XSlope (%)	1.4
			N/A	Flare Type LT	N/A	N/A	Flare Type RT	N/A
			N/A	Flare Slope LT (%)	N/A	N/A	Flare Slope RT (%)	N/A
			N/A	Flare Traversable LT?	N/A	N/A	Flare Traversable RT?	N/A
	Surveyor Notes:		N/A	Landing Length (in)	N/A	N/A	DWS Provided?	N/A
			N/A	Landing Width (in)	N/A	N/A	DWS Contrast?	N/A
			N/A	Landing Slope (%)	N/A	N/A	DWS Length (in)	N/A
			N/A	Landing X Slope (%)	N/A	N/A	DWS Full Width?	N/A
N/A			Landing Curb? (Y/N)	N/A	N/A	DWS Offset (in)	N/A	
PROW/ADA:		N/A	Shared Landing?	N/A				
<b>Not Found, R304.2.2</b>		N/A	Gutter Ponding?	N/A	N/A	Gutter Slope (%)	N/A

N/A	Gutter Lip Ht (in)	N/A	N/A	Gutter X Slope (%)	N/A	
		N/A	Painted X Walk1?	No	N/A	Painted X Walk2?	No	
			X Walk 1 Direction	To S		X Walk 2 Direction	To SE	
		N/A	X Walk 1 Width (in)	N/A	N/A	X Walk 2 Width (in)	N/A	
			X Walk 1 Slope (%)	3.5		X Walk 2 Slope (%)	5.0	
			X Walk 1 X Slope (%)	0.7		X Walk 2 X Slope (%)	2.7	
		N/A	Ramp inside XWalk1?	N/A	N/A	Ramp inside XWalk2?	N/A	
			Road Slope (%)	1.8	N/A	Clear Space?	N/A	
			Road X Slope (%)	5.2	N/A	Clear Space to XWalk (in)	N/A	
		N/A	Any Obstructions?	N/A	N/A	Storm Grate/Utility Hazard?	N/A	
			Obstruction Type			Storm Grate/Utility Type		
					N/A		N/A	
					Yes	Surface Condition? (G/P)	Good	
Street 1 Name		HILLSIDE AV						
Stop Condition-Street 2		StopSign						
Street 2 Name		WESTFIELD RD						
Stop Condition-Street 1		StopSign						
Total Cost:		\$ 3200.00
