# Access Compliance Report

## Public Rights-of-Way

### (Curb Ramps)

Intersection ID: 3740	Main Street: CHESTNUT_KNOLL_LN	Cross Street: DAVIS_LAKE_PY	Location: S
ADA ID: 9CAF9109A4B4	Ramp Type: Perp	Initial Pass/Fail: Fail	Overall Compliance: No
Severity Score: 10			
Codes/Mitigation Info/Possible Solution		Field Measurements/Component Compliance

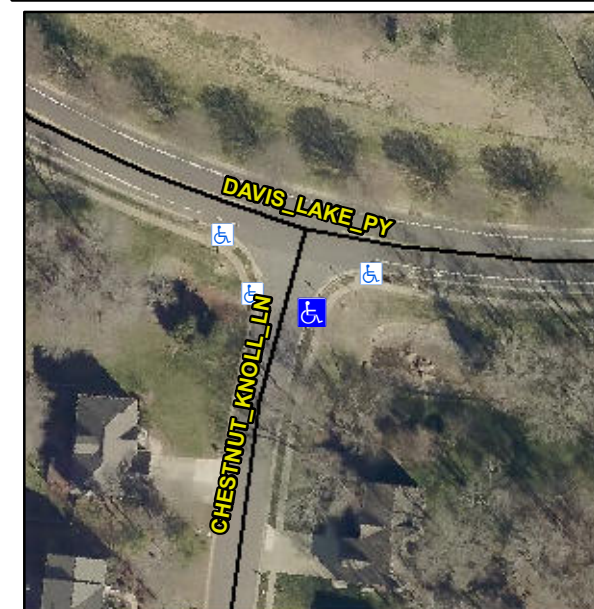
**Not Found, R304.5.1, R304.5.3**

Compliance	Description	Data	Compliance	Description	Data
N/A	Ramp Length (in)	55.0	Yes	Ramp Slope (%)	5.5
No	Ramp Width (in)	46.0	No	Ramp XSlope (%)	2.1
N/A	Flare Type LT	N/A	N/A	Flare Type RT	N/A
N/A	Flare Slope LT (%)	N/A	N/A	Flare Slope RT (%)	N/A
N/A	Flare Traversable LT?	N/A	N/A	Flare Traversable RT?	N/A
N/A	Landing Length (in)	N/A	N/A	DWS Provided?	N/A
N/A	Landing Width (in)	N/A	N/A	DWS Contrast?	N/A
N/A	Landing Slope (%)	N/A	N/A	DWS Length (in)	N/A
N/A	Landing X Slope (%)	N/A	N/A	DWS Full Width?	N/A
N/A	Landing Curb? (Y/N)	N/A	N/A	DWS Offset (in)	N/A
N/A	Shared Landing?	N/A			
N/A	Gutter Ponding?	N/A	N/A	Gutter Slope (%)	N/A
N/A	Gutter Lip Ht (in)	N/A	N/A	Gutter X Slope (%)	N/A
N/A	Painted X Walk1?	No	N/A	Painted X Walk2?	N/A
	X Walk 1 Direction	To NW		X Walk 2 Direction	N/A
N/A	X Walk 1 Width (in)	N/A	N/A	X Walk 2 Width (in)	N/A
	X Walk 1 Slope (%)	5.9		X Walk 2 Slope (%)	N/A
	X Walk 1 X Slope (%)	1.4		X Walk 2 X Slope (%)	N/A

N/A	Ramp inside XWalk1?	N/A	N/A	Ramp inside XWalk2?	N/A
	Road Slope (%)	N/A	N/A	Clear Space?	N/A
	Road X Slope (%)	N/A	N/A	Clear Space to XWalk (in)	N/A
N/A	Any Obstructions?	N/A	N/A	Storm Grate/Utility Hazard?	N/A
	Obstruction Type			Storm Grate/Utility Type	
		N/A			N/A
			Yes	Surface Condition? (G/P)	Good

**Remove & Replace Entire Ramp.**
