## Access Compliance Report Public Rights-of-Way (Curb Ramps)

Intersection ID: N/A Main Street: REGAL\_ESTATE\_LN Cross Street: WILORA\_LAKE\_RD Location: NE

ADA ID: 9CB17B3CAAAB Ramp Type: PerpDiag Initial Pass/Fail: Fail Overall Compliance: No Severity Score: 18.75

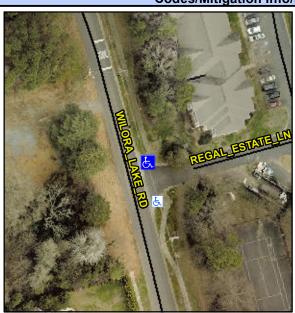
Not Found, R304.5.1, R304.5.3

Field Measurements/Component Compliance							
	Compli	ance Description	Data	Compli	ance	Description	Data
	N/A	Ramp Length (in)	96.0	Yes	Ramp	Slope (%)	6.3
	No	Ramp Width (in)	35.0	No	Ramp	XSlope (%)	3.1
	N/A	Flare Type LT	N/A	N/A	Flare	Type RT	N/A
	N/A	Flare Slope LT (%)	N/A	N/A	Flare	Slope RT (%)	N/A
	N/A	Flare Traversable LT?	N/A	N/A	Flare	Traversable RT?	N/A
	N/A	Landing Length (in)	N/A	N/A	DWS	Provided?	N/A
	N/A	Landing Width (in)	N/A	N/A	DWS	Contrast?	N/A
	N/A	Landing Slope (%)	N/A	N/A	DWS	Length (in)	N/A
	N/A	Landing X Slope (%)	N/A	N/A	DWS	Full Width?	N/A
	N/A	Landing Curb? (Y/N)	N/A	N/A	DWS	Offset (in)	N/A
	N/A	Shared Landing?	N/A				
	N/A	Gutter Ponding?	N/A	N/A	Gutter	Slope (%)	N/A
	N/A	Gutter Lip Ht (in)	N/A	N/A	Gutter	X Slope (%)	N/A
	N/A	Painted X Walk1?	No	N/A	Painte	ed X Walk2?	No
		X Walk 1 Direction	To W		X Wal	k 2 Direction	To S
	N/A	X Walk 1 Width (in)	N/A	N/A	X Wal	k 2 Width (in)	N/A
		X Walk 1 Slope (%)	0.9		X Wal	k 2 Slope (%)	0.6

X Walk 1 X Slope (%)	1.5		X Wal	k 2 X Slope (%)	0.0
	N/A	Ramp inside XWalk1?	N/A	N/A	Ramp	inside XWalk2?	N/A
		Road Slope (%)	0.4	N/A	Clear	Space?	N/A
		Road X Slope (%)	0.7	N/A	Clear	Space to XWalk (in)	N/A
	N/A	Any Obstructions?	N/A	N/A	Storm	Grate/Utility Hazard?	N/A
		Obstruction Type			Storm	Grate/Utility Type

Remove & Replace Curb Ramp With Two New Directional Ramps or Equivalent.

Total Cost: \$ 3200.00
