## **Access Compliance Report Public Rights-of-Way** (Curb Ramps)

Intersection ID: 23944 Main Street: BOSHAM LN Cross Street: PRESCOTT\_POND\_LN Location: ADA ID: 9CB90A8102C5 Ramp Type: Perp Initial Pass/Fail: Fail **Overall Compliance: No** Severity Score: 13.75

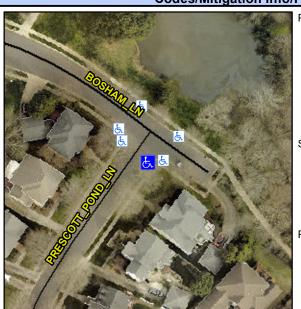
Fleid Measurements/Component Compilance							
Comp	liance Description	Data	Comp	liance Description	Data		
N/A	Ramp Length (in)	48.0	No	Ramp Slope (%)	8.7		
Yes	Ramp Width (in)	48.2	No	Ramp XSlope (%)	4.9		
N/A	Flare Type LT	N/A	N/A	Flare Type RT	N/A		
N/A	Flare Slope LT (%)	N/A	N/A	Flare Slope RT (%)	N/A		
N/A	Flare Traversable LT?	N/A	N/A	Flare Traversable RT?	N/A		
N/A	Landing Length (in)	N/A	N/A	DWS Provided?	N/A		
N/A	Landing Width (in)	N/A	N/A	DWS Contrast?	N/A		
N/A	Landing Slope (%)	N/A	N/A	DWS Length (in)	N/A		
N/A	Landing X Slope (%)	N/A	N/A	DWS Full Width?	N/A		
N/A	Landing Curb? (Y/N)	N/A	N/A	DWS Offset (in)	N/A		
N/A	Shared Landing?	N/A					
N/A	Gutter Ponding?	N/A	N/A	Gutter Slope (%)	N/A		
N/A	Gutter Lip Ht (in)	N/A	N/A	Gutter X Slope (%)	N/A		
N/A	Painted X Walk1?	No	N/A	Painted X Walk2?	N/A		
	X Walk 1 Direction	To NW		X Walk 2 Direction	N/A		
N/A	X Walk 1 Width (in)	N/A	N/A	X Walk 2 Width (in)	N/A

X Walk 1 Slope (%)	5.4		X Walk 2 Slope (%)	N/A		
	X Walk 1 X Slope (%)	2.1		X Walk 2 X Slope (%)	N/A		
N/A	Ramp inside XWalk1?	N/A	N/A	Ramp inside XWalk2?	N/A		
	Road Slope (%)	N/A	N/A	Clear Space?	N/A		
	Road X Slope (%)	N/A	N/A	Clear Space to XWalk (in)	N/A		
N/A	Any Obstructions?	N/A	N/A	Storm Grate/Utility Hazard?	N/A		
	Obstruction Type			Storm Grate/Utility Type			
		N/A			N/A		
			Yes	Surface Condition? (G/P)	Good

71 OSSIDIE OCIULION	
Possible Solutions:	9
Remove & Replace Entire Ramp.	ı
	`
	ı
	ı
	ı
	ı
Surveyor Notes:	ı
N/A	ı
	ı
	ı
	ı
PROW/ADA:	ı
Not Found, R304.2.2, R304.5.3	ı
	ı
	ı
