## Access Compliance Report Public Rights-of-Way (Curb Ramps)

Intersection ID: 8226 Main Street: CATHERINE_SIMMONS_AV Cross Street: CUSTER_ST								Location:	NW
ADA ID: 9CC7FAB5CED7 Ramp Type: PerpDiag			Initial P	itial Pass/Fail: Fail Overall Compliance: No				o Severity Score:	21.25
Codes/Mitigation Info/Possible Solution				Field Measurements/Component Compliance					
August		Possible Solutions:		Compliance Description		Data	Data Compliance Description		Data
		Remove & Replace Curb Ramp With Two New Directional Ramps or Equivalent.	Vith	N/A	Ramp Length (in)	61.0	No	Ramp Slope (%)	9.4
				No	Ramp Width (in)	47.0	Yes	Ramp XSlope (%)	0.7
				N/A	Flare Type LT	N/A	N/A	Flare Type RT	N/A
				N/A	Flare Slope LT (%)	N/A	N/A	Flare Slope RT (%)	N/A
				N/A	Flare Traversable LT?	N/A	N/A	Flare Traversable RT?	N/A
				N/A	Landing Length (in)	N/A	N/A	DWS Provided?	N/A
		Surveyor Notes:		N/A	Landing Width (in)	N/A	N/A	DWS Contrast?	N/A
A starting		N/A		N/A	Landing Slope (%)	N/A	N/A	DWS Length (in)	N/A

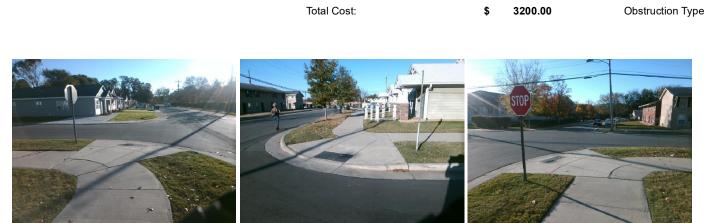
CATHERINE SIMMONS /	w g			N/A	Landing X Slope (%)	N/A	N/A	DWS Full Width?	N/A
				N/A	Landing Curb? (Y/N)	N/A	N/A	DWS Offset (in)	N/A
			N/A	Shared Landing?	N/A				
	PROW/ADA:		N/A	Gutter Ponding?	N/A	N/A	Gutter Slope (%)	N/A	
and the second s		Not Found, R304.5.1, R304.2.2		N/A	Gutter Lip Ht (in)	N/A	N/A	Gutter X Slope (%)	N/A
				N/A	Painted X Walk1?	No	N/A	Painted X Walk2?	No
					X Walk 1 Direction	To S		X Walk 2 Direction	To E
				N/A	X Walk 1 Width (in)	N/A	N/A	X Walk 2 Width (in)	N/A
Street 1 Name	CATHERINE SIMMONS AV				X Walk 1 Slope (%)	1.0		X Walk 2 Slope (%)	0.1
Stop Condition-Street 2	None				X Walk 1 X Slope (%)	0.5		X Walk 2 X Slope (%)	1.5
Street 2 Name	CUSTER ST			N/A	Ramp inside XWalk1?	N/A	N/A	Ramp inside XWalk2?	N/A
Stop Condition-Street 1	StopSign				Road Slope (%)	0.5	N/A	Clear Space?	N/A
					Road X Slope (%)	0.5	N/A	Clear Space to XWalk (in)	N/A
				N/A	Any Obstructions?	N/A	N/A	Storm Grate/Utility Hazard?	N/A

Total Cost: \$ 3	200.00		Obstruction Type			Storm Grate/Utility Type	
						N/A			N/A
4							L
