Access Compliance Report Public Rights-of-Way (Curb Ramps)

Intersection ID: 54217Main Street:GOLF_LINKS_DRCross Street:MIDWAY_PARK_DRLocation:NWADA ID: 9CDAD4021A52Ramp Type:PerpInitial Pass/Fail:FailOverall Compliance:NoSeverity Score:12.5

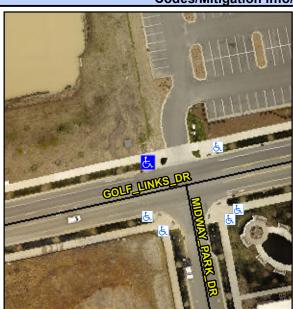
Field Measurements/Component Compliance							
Comp	liance Description	Data	Comp	liance Description	Data		
N/A	Ramp Length (in)	94.0	No	Ramp Slope (%)	9.0		
Yes	Ramp Width (in)	60.0	Yes	Ramp XSlope (%)	1.3		
N/A	Flare Type LT	N/A	N/A	Flare Type RT	N/A		
N/A	Flare Slope LT (%)	N/A	N/A	Flare Slope RT (%)	N/A		
N/A	Flare Traversable LT?	N/A	N/A	Flare Traversable RT?	N/A		
N/A	Landing Length (in)	N/A	N/A	DWS Provided?	N/A		
N/A	Landing Width (in)	N/A	N/A	DWS Contrast?	N/A		
N/A	Landing Slope (%)	N/A	N/A	DWS Length (in)	N/A		
N/A	Landing X Slope (%)	N/A	N/A	DWS Full Width?	N/A		
N/A	Landing Curb? (Y/N)	N/A	N/A	DWS Offset (in)	N/A		
N/A	Shared Landing?	N/A					
N/A	Gutter Ponding?	N/A	N/A	Gutter Slope (%)	N/A		
N/A	Gutter Lip Ht (in)	N/A	N/A	Gutter X Slope (%)	N/A		
N/A	Painted X Walk1?	No	N/A	Painted X Walk2?	N/A		
	X Walk 1 Direction	To S		X Walk 2 Direction	N/A		
N/A	X Walk 1 Width (in)	N/A	N/A	X Walk 2 Width (in)	N/A

X Walk 1 Slope (%)	5.0		X Walk 2 Slope (%)	N/A		
	X Walk 1 X Slope (%)	0.9		X Walk 2 X Slope (%)	N/A		
N/A	Ramp inside XWalk1?	N/A	N/A	Ramp inside XWalk2?	N/A		
	Road Slope (%)	N/A	N/A	Clear Space?	N/A		
	Road X Slope (%)	N/A	N/A	Clear Space to XWalk (in)	N/A		
N/A	Any Obstructions?	N/A	N/A	Storm Grate/Utility Hazard?	N/A		
	Obstruction Type			Storm Grate/Utility Type			
		N/A			N/A		
			Yes	Surface Condition? (G/P)	Good

i essible colution			
Possible Solutions:	Comp	Compliance	
Remove & Replace Entire Ramp.	N/A	Ramp	
·	Yes	Ramp	
	N/A	Flare	
	N/A	Flare	
	N/A	Flare	
	N/A	Landi	
Surveyor Notes:	N/A	Landi	
N/A	N/A	Landi	
	N/A	Landi	
	N/A	Landi	
	N/A	Share	
PROW/ADA:	N/A	Gutte	
Not Found, R304.2.2	N/A	Gutte	
	N/A	Painte	
		X Wal	
	N/A	X Wal	
		X Wal	
		X Wal	
	N/A	Ramp	
		Road	
		Dood
