# Access Compliance Report

## Public Rights-of-Way

### (Curb Ramps)

Intersection ID: N/A	Main Street: LANGWELL_LN	Cross Street: INVERNESS_BAY_RD	Location: SE
ADA ID: 9CDECBA2AE01	Ramp Type: Perp	Initial Pass/Fail: Fail	Overall Compliance: No
Severity Score: 13.75			
Codes/Mitigation Info/Possible Solution		Field Measurements/Component Compliance

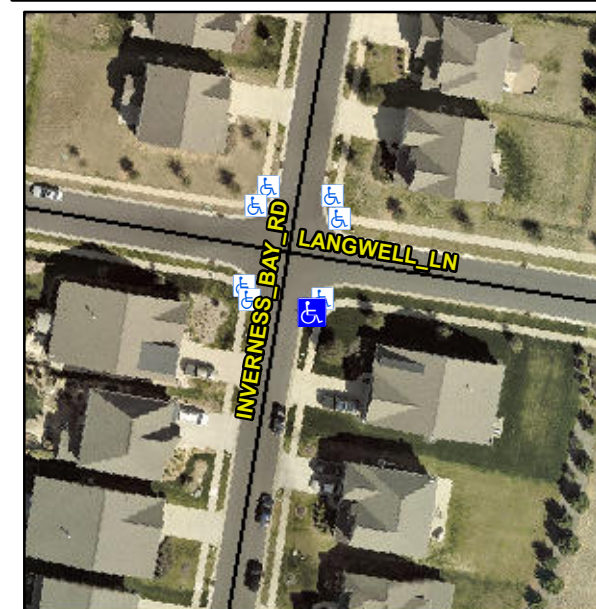
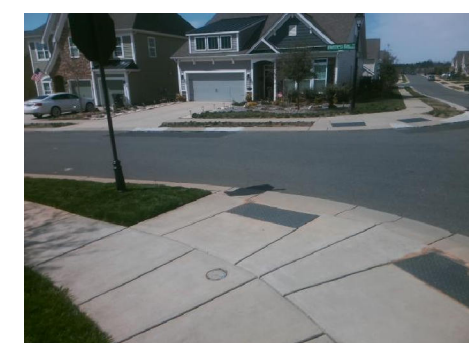
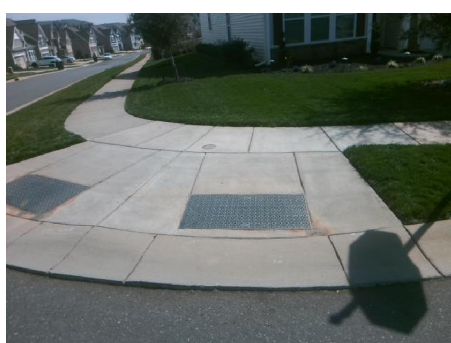
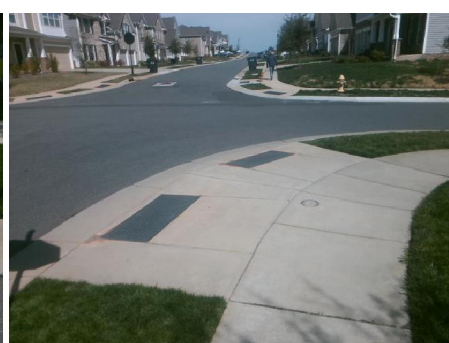
Compliance	Description	Data	Compliance	Description	Data
N/A	Ramp Length (in)	74.0	No	Ramp Slope (%)	8.8
Yes	Ramp Width (in)	48.0	No	Ramp XSlope (%)	4.4
N/A	Flare Type LT	N/A	N/A	Flare Type RT	N/A
N/A	Flare Slope LT (%)	N/A	N/A	Flare Slope RT (%)	N/A
N/A	Flare Traversable LT?	N/A	N/A	Flare Traversable RT?	N/A
N/A	Landing Length (in)	N/A	N/A	DWS Provided?	N/A
N/A	Landing Width (in)	N/A	N/A	DWS Contrast?	N/A
N/A	Landing Slope (%)	N/A	N/A	DWS Length (in)	N/A
N/A	Landing X Slope (%)	N/A	N/A	DWS Full Width?	N/A
N/A	Landing Curb? (Y/N)	N/A	N/A	DWS Offset (in)	N/A
N/A	Shared Landing?	N/A			
N/A	Gutter Ponding?	N/A	N/A	Gutter Slope (%)	N/A
N/A	Gutter Lip Ht (in)	1.0	N/A	Gutter X Slope (%)	N/A
N/A	Painted X Walk1?	No	N/A	Painted X Walk2?	N/A
	X Walk 1 Direction	To W		X Walk 2 Direction	N/A
N/A	X Walk 1 Width (in)	N/A	N/A	X Walk 2 Width (in)	N/A
	X Walk 1 Slope (%)	7.0		X Walk 2 Slope (%)	N/A
	X Walk 1 X Slope (%)	3.9		X Walk 2 X Slope (%)	N/A

N/A	Ramp inside XWalk1?	N/A	N/A	Ramp inside XWalk2?	N/A
	Road Slope (%)	N/A	N/A	Clear Space?	N/A
	Road X Slope (%)	N/A	N/A	Clear Space to XWalk (in)	N/A
N/A	Any Obstructions?	N/A	N/A	Storm Grate/Utility Hazard?	N/A
	Obstruction Type			Storm Grate/Utility Type	
		N/A			N/A
		Yes		Surface Condition? (G/P)	Good

**Remove & Replace Entire Ramp.**

**R304.2.2, R304.5.3**
