Access Compliance Report

Public Rights-of-Way

(Curb Ramps)

| Intersection ID: 14879 | Main Street: ROSEHAVEN_DR | Cross Street: WINTERFIELD_PL | Location: NW |

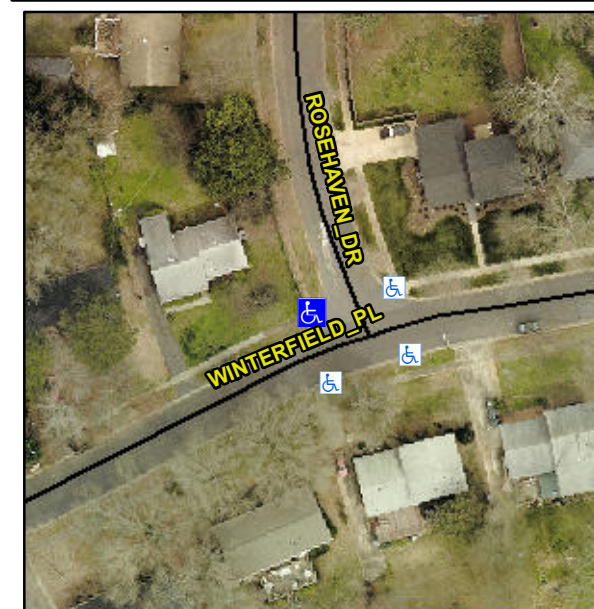
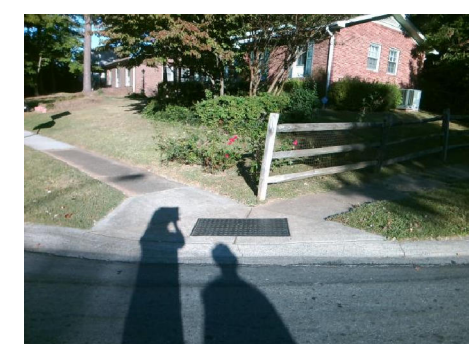
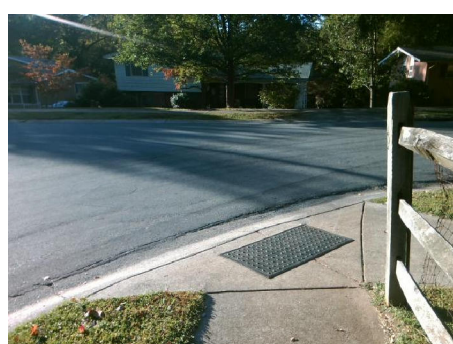
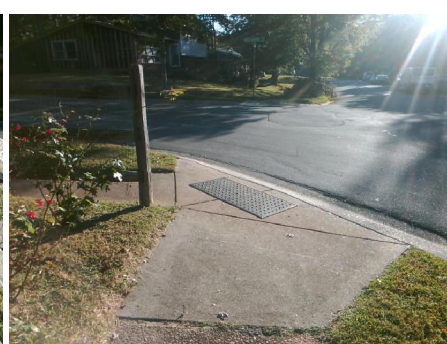
| ADA ID: 9CDF30608F59 | Ramp Type: PerpDiag | Initial Pass/Fail: Fail | Overall Compliance: No |
| Severity Score: 12.5 | | | |

Not Found, R304.5.3

| Compliance | Description | Data | Compliance | Description | Data |
|---|---|---|---|---|---|
| Yes | Ramp Width (in) | 48.0 | No | Ramp XSlope (%) | 5.9 |

Remove & Replace Curb Ramp With Two New Directional Ramps or Equivalent.

Total Cost: \$ 3200.00
