Access Compliance Report

Public Rights-of-Way

(Curb Ramps)

Intersection ID: 47646	Main Street: ALDWYCH_WY	Cross Street: DESHLER_MORRIS_LN	Location: SW
ADA ID: 9CEAF8515A6E	Ramp Type: PerpDiag	Initial Pass/Fail: Fail	Overall Compliance: No
Severity Score: 22.5			
Codes/Mitigation Info/Possible Solution		Field Measurements/Component Compliance

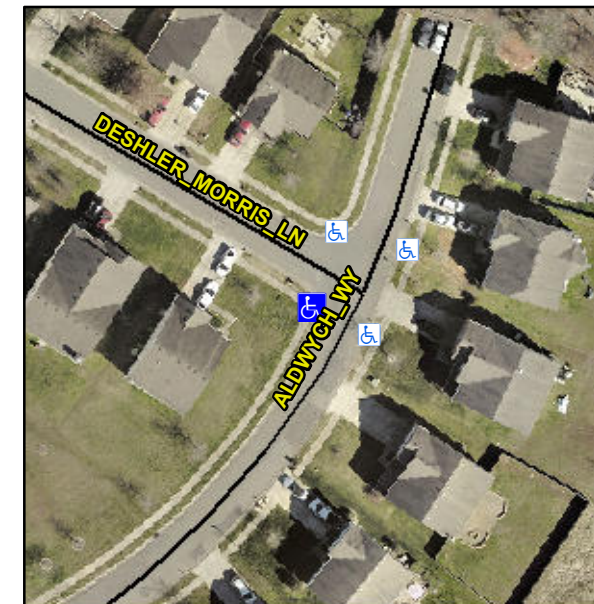
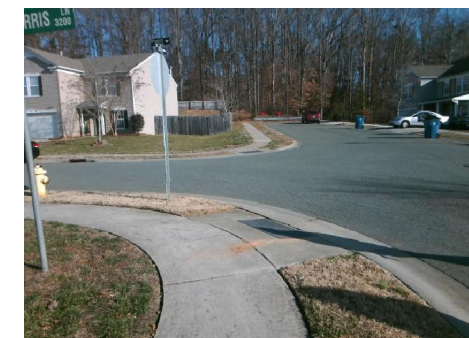
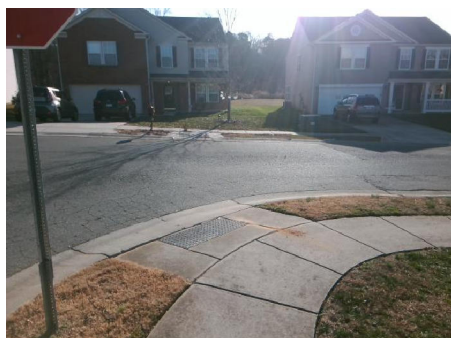
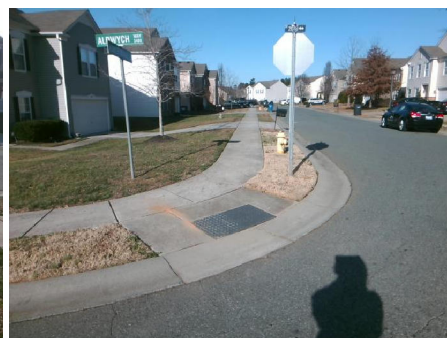
Not Found, R304.5.1, R304.2.2, R304.5.3

Compliance	Description	Data	Compliance	Description	Data
N/A	Ramp Length (in)	47.0	No	Ramp Slope (%)	11.4
No	Ramp Width (in)	46.5	No	Ramp XSlope (%)	2.8
N/A	Flare Type LT	N/A	N/A	Flare Type RT	N/A
N/A	Flare Slope LT (%)	N/A	N/A	Flare Slope RT (%)	N/A
N/A	Flare Traversable LT?	N/A	N/A	Flare Traversable RT?	N/A
N/A	Landing Length (in)	N/A	N/A	DWS Provided?	N/A
N/A	Landing Width (in)	N/A	N/A	DWS Contrast?	N/A
N/A	Landing Slope (%)	N/A	N/A	DWS Length (in)	N/A
N/A	Landing X Slope (%)	N/A	N/A	DWS Full Width?	N/A
N/A	Landing Curb? (Y/N)	N/A	N/A	DWS Offset (in)	N/A
N/A	Shared Landing?	N/A			
N/A	Gutter Ponding?	N/A	N/A	Gutter Slope (%)	N/A
N/A	Gutter Lip Ht (in)	N/A	N/A	Gutter X Slope (%)	N/A
N/A	Painted X Walk1?	No	N/A	Painted X Walk2?	No
	X Walk 1 Direction	To SE		X Walk 2 Direction	To NE
N/A	X Walk 1 Width (in)	N/A	N/A	X Walk 2 Width (in)	N/A
	X Walk 1 Slope (%)	0.5		X Walk 2 Slope (%)	4.6
	X Walk 1 X Slope (%)	3.8		X Walk 2 X Slope (%)	0.5

N/A	Ramp inside XWalk1?	N/A	N/A	Ramp inside XWalk2?	N/A
	Road Slope (%)	3.4	N/A	Clear Space?	N/A
	Road X Slope (%)	4.1	N/A	Clear Space to XWalk (in)	N/A
N/A	Any Obstructions?	N/A	N/A	Storm Grate/Utility Hazard?	N/A
	Obstruction Type			Storm Grate/Utility Type	
		N/A			N/A
			Yes	Surface Condition? (G/P)	Good

Remove & Replace Curb Ramp With Two New Directional Ramps or Equivalent.
