# Access Compliance Report Public Rights-of-Way (Curb Ramps)

| Intersection ID: N/A | Main Street: PERTH_MOOR_RD | Cross Street: HAMILTON_BRIDGE_RD | Location: NE |
| ADA ID: 9CEF522D1758 | Ramp Type: Perp | Initial Pass/Fail: Fail | Overall Compliance: No |

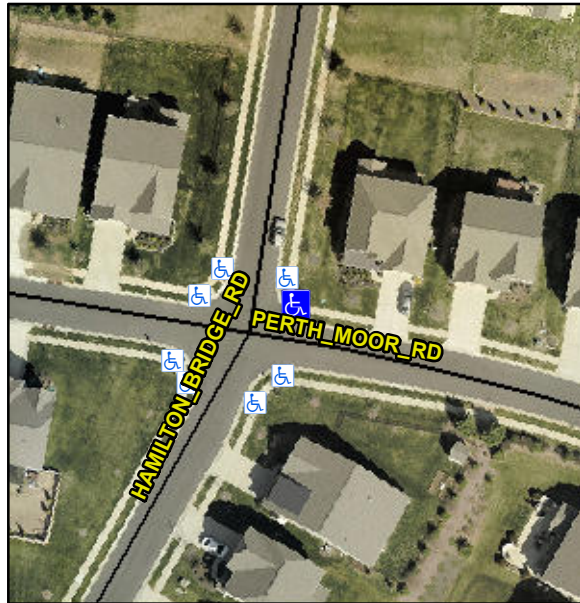
**R304.5.1, R304.2.2, R304.5.3**

| Compliance | Description | Data | Compliance | Description | Data |
|---|---|---|---|---|---|
| N/A | Ramp Length (in) | 47.0 | No | Ramp Slope (%) | 13.1 |
| No | Ramp Width (in) | 44.0 | No | Ramp XSlope (%) | 11.2 |

**Remove & Replace Entire Ramp.**
