## Access Compliance Report Public Rights-of-Way (Curb Ramps)

Intersection ID: 10027726	Main Str	reet: GRIFFITH_RD	Cross	Street:	N/A	Location:	SW		
ADA ID: 9CF7522A3D31	Ramp Type: PerpDiag			Initial Pass/Fail: Fail Overall Compliance: No				o Severity Score:	46.25
Codes/Mitigation Info/Possible Solution				Field Measurements/Component Compliance					
		Possible Solutions:					liance Description	Data

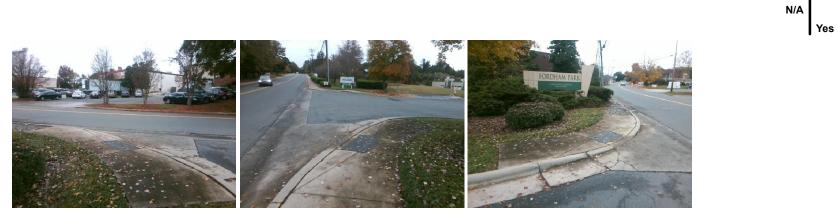
E.	Remove & Replace Curb Ramp	With	N/A	Ramp Length (in)	30.0	No	Ramp Slope (%)	8.5
		Two New Directional Ramps of		No	Ramp Width (in)	47.0	No	Ramp XSlope (%)	7.4
		Equivalent.		N/A	Flare Type LT	N/A	N/A	Flare Type RT	N/A
				N/A	Flare Slope LT (%)	N/A	N/A	Flare Slope RT (%)	N/A
				N/A	Flare Traversable LT?	N/A	N/A	Flare Traversable RT?	N/A
The state		-		N/A	Landing Length (in)	N/A	N/A	DWS Provided?	N/A
e Co		Surveyor Notes:		N/A	Landing Width (in)	N/A	N/A	DWS Contrast?	N/A
		N/A		N/A	Landing Slope (%)	N/A	N/A	DWS Length (in)	N/A
A STA				N/A	Landing X Slope (%)	N/A	N/A	DWS Full Width?	N/A
				N/A	Landing Curb? (Y/N)	N/A	N/A	DWS Offset (in)	N/A
				N/A	Shared Landing?	N/A			
		PROW/ADA:		N/A	Gutter Ponding?	N/A	N/A	Gutter Slope (%)	N/A
a o star		R304.5.1, R304.2.2, R304.5.3		N/A	Gutter Lip Ht (in)	N/A	N/A	Gutter X Slope (%)	N/A
		,,,,,,,		N/A	Painted X Walk1?	No	N/A	Painted X Walk2?	No

*			X Walk 1 Direction	To NE		X Walk 2 Direction	To NW
				N/A	X Walk 1 Width (in)	N/A	N/A	X Walk 2 Width (in)	N/A
Street 1 Name	ENTRANCE	_			X Walk 1 Slope (%)	1.1		X Walk 2 Slope (%)	5.7
Stop Condition-Street 2	StopSign				X Walk 1 X Slope (%)	0.7		X Walk 2 X Slope (%)	2.2
Street 2 Name	<b>GRIFFITH RD</b>			N/A	Ramp inside XWalk1?	N/A	N/A	Ramp inside XWalk2?	N/A
Stop Condition-Street 1	None				Road Slope (%)	1.0	N/A	Clear Space?	N/A
					Road X Slope (%)	3.1	N/A	Clear Space to XWalk (in)	N/A
				N/A	Any Obstructions?	N/A	N/A	Storm Grate/Utility Hazard?	N/A
		Total Cost: \$	3200.00		Obstruction Type			Storm Grate/Utility Type	
						N/A			N/A
