## **Access Compliance Report Public Rights-of-Way** (Curb Ramps)

Intersection ID: 10031407 Main Street: MCALPINE\_STATION\_DR **Cross Street: N/A** Location: NW ADA ID: 9D0148CE19C3 Ramp Type: PerpDiag Initial Pass/Fail: Fail **Overall Compliance: No** Severity Score: 33.75

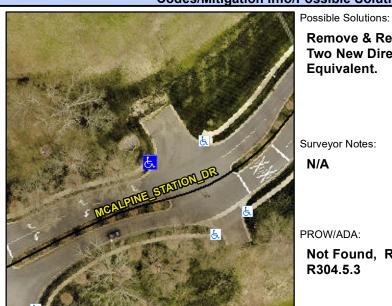
| Not Found,<br>R304.5.3 | R304.5.1, R304.2.2, | | | | | |

| Comp | liance Description | Data | | oliance Description | Data | |
|---|---|---|---|---|---|--|
| N/A | Ramp Length (in) | 47.0 | No | Ramp Slope (%) | 10.2 | |
| No | Ramp Width (in) | 47.5 | No | Ramp XSlope (%) | 6.6 | |

Street 1 Name MCALPINE STATION DR Stop Condition-Street 2 None Street 2 Name N/A Stop Condition-Street 1 None **Remove & Replace Curb Ramp With Two New Directional Ramps or** Equivalent.
