Access Compliance Report

Public Rights-of-Way (Curb Ramps)

Intersection ID: 11284	Main Street: MEADOWCLIFF_DR	Cross Street: STEPPING_STONE_DR	Location: NW
ADA ID: 9D09876B0716	Ramp Type: Directional1	Initial Pass/Fail: Fail	Overall Compliance: No
Codes/Mitigation Info/Possible Solution		Field Measurements/Component Compliance

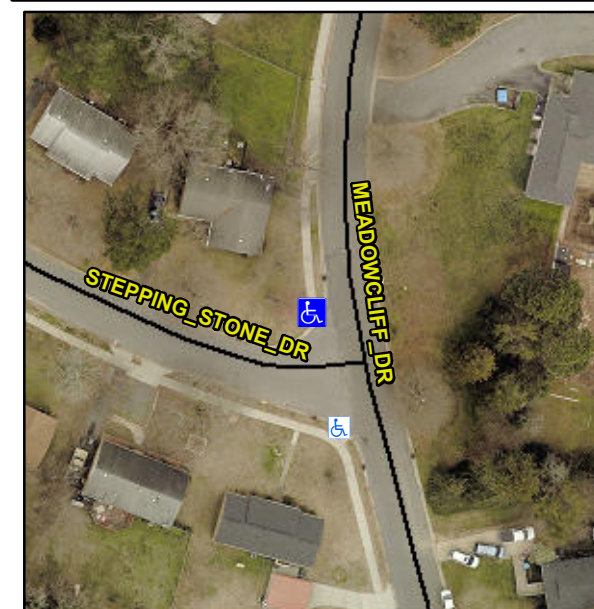
Compliance	Description	Data	Compliance	Description	Data
N/A	Ramp Length (in)	197.5	N/A	Grade Break?	N/A
Yes	Ramp Width (in)	60.0	N/A	Grade Break Slope (%)	0.0
Yes	Ramp Slope (%)	5.2	N/A	Grade Break XSlope (%)	0.0
No	Ramp XSlope (%)	3.2			
N/A	Flare Type LT	N/A	N/A	Flare Type RT	N/A
N/A	Flare Slope LT (%)	N/A	N/A	Flare Slope RT (%)	0.0
N/A	Flare Traversable LT?	N/A	N/A	Flare Traversable RT?	N/A
N/A	Landing Length (in)	0.0	N/A	DWS Provided?	N/A
N/A	Landing Width (in)	0.0	N/A	DWS Contrast?	N/A
N/A	Landing Slope (%)	0.0	N/A	DWS Length (in)	N/A
N/A	Landing X Slope (%)	0.0	N/A	DWS Full Width?	N/A
N/A	Landing Curb? (Y/N)	N/A	N/A	DWS Offset LT (in)	N/A
N/A	Shared Landing?	N/A	N/A	DWS Offset RT (in)	N/A
N/A	Gutter Ponding?	0.0	N/A	Gutter Slope (%)	N/A
N/A	Gutter Lip Ht (in)	0.0	N/A	Gutter X Slope (%)	N/A
N/A	Painted X Walk1?	No		Road Slope (%)	2.1
	X Walk 1 Direction	To S		Road X Slope (%)	0.0
	X Walk 1 Width (in)	N/A		Clear Space?	N/A

X Walk 1 Slope (%)	2.1	N/A	Clear Space to XWalk (in)	N/A
	X Walk 1 X Slope (%)	0.0	N/A	Storm Grate/Utility Hazard?	N/A
N/A	Ramp inside XWalk1?	N/A		Storm Grate/Utility Type	
N/A	Any Obstructions?	N/A			N/A
	Obstruction Type		Yes	Surface Condition? (G/P)	Good
			N/A	Curb Slope (%)	12.0

Possible Solutions:

Remove & Replace Entire Ramp.

R304.5.3

\$ 1600.00
