## Access Compliance Report Public Rights-of-Way (Curb Ramps)

-							
Intersection ID: 20968	ection ID: 20968 Main Street: CURRAGHMORE_RD			Cross Street: SHARON_VIEW_RD				Location:	Е
ADA ID: 9D0B693EF036	Ramp Ty	Ramp Type: PerpDiag			ail: Fail Overall	nce: N	o Severity Score:	10	
Codes/Mitigation Info/Possible Solution				Field Measurements/Component Compliance					
	N/ Merchan	Possible Solutions:		Compliance Description		Data Compliance Description			Data
		Remove & Replace Curb Ramp Wi Two New Directional Ramps or Equivalent.	o With	N/A	Ramp Length (in)	108.0	Yes	Ramp Slope (%)	7.6
				No	Ramp Width (in)	37.0	No	Ramp XSlope (%)	4.6
				N/A	Flare Type LT	N/A	N/A	Flare Type RT	N/A
				N/A	Flare Slope LT (%)	N/A	N/A	Flare Slope RT (%)	N/A
ET I	14			N/A	Flare Traversable LT?	N/A	N/A	Flare Traversable RT?	N/A
E 8	All and a state a	And A		N/A	Landing Length (in)	N/A	N/A	DWS Provided?	N/A
	and the second second	Surveyor Notes:		N/A	Landing Width (in)	N/A	N/A	DWS Contrast?	N/A

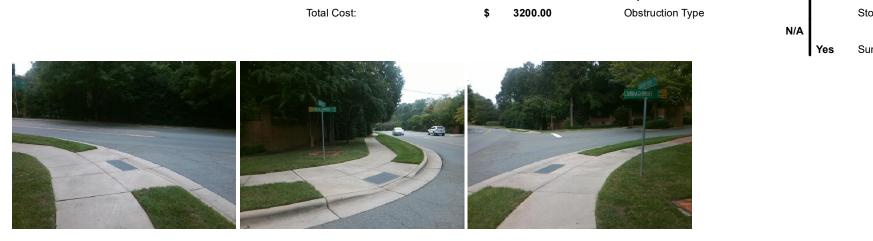
Starte Starte	Contraction of the	N/A		N/A	Landing Slope (%)	N/A	N/A	DWS Length (in)	N/A
the second	Dra Charles and			N/A	Landing X Slope (%)	N/A	N/A	DWS Full Width?	N/A
The second second	AN AN			N/A	Landing Curb? (Y/N)	N/A	N/A	DWS Offset (in)	N/A
6			N/A	Shared Landing?	N/A				
	With a start	PROW/ADA:		N/A	Gutter Ponding?	N/A	N/A	Gutter Slope (%)	N/A
Not Found, R304.5.1, R304.5.3			}	N/A	Gutter Lip Ht (in)	N/A	N/A	Gutter X Slope (%)	N/A
				N/A	Painted X Walk1?	No	N/A	Painted X Walk2?	No
					X Walk 1 Direction	To NW		X Walk 2 Direction	To SW
				N/A	X Walk 1 Width (in)	N/A	N/A	X Walk 2 Width (in)	N/A
Street 1 Name	CURRAGHMORE RD	_			X Walk 1 Slope (%)	4.4		X Walk 2 Slope (%)	0.7
Stop Condition-Street 2	StopSign				X Walk 1 X Slope (%)	2.3		X Walk 2 X Slope (%)	3.3
Street 2 Name	SHARON VIEW RD			N/A	Ramp inside XWalk1?	N/A	N/A	Ramp inside XWalk2?	N/A
Stop Condition-Street 1	None				Road Slope (%)	3.7	N/A	Clear Space?	N/A

Road X Slope (%)	1.8	N/A	Clear Space to XWalk (in)	N/A
				N/A	Any Obstructions?	N/A	N/A	Storm Grate/Utility Hazard?	N/A
		Total Cost: \$	3200.00		Obstruction Type			Storm Grate/Utility Type	
						N/A			N/A
