Access Compliance Report

Public Rights-of-Way

(Curb Ramps)

| Intersection ID: 3937 | Main Street: CULLINGFORD_LN | Cross Street: ROYCE_HALL_LN | Location: SE |

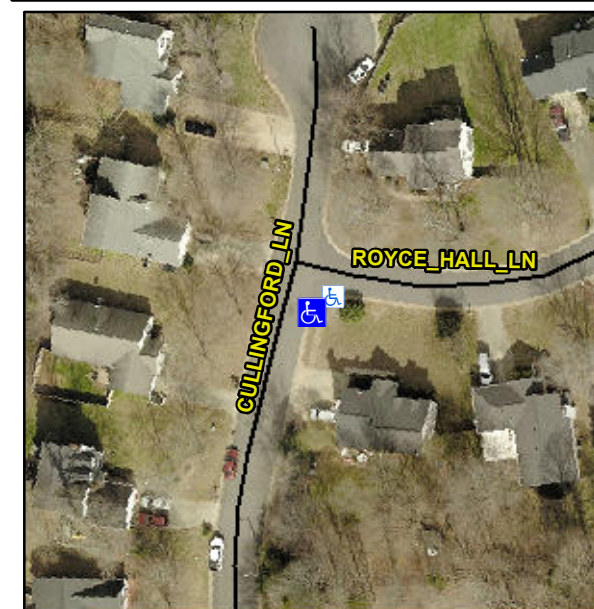
| ADA ID: 9D1EBCDF4273 | Ramp Type: Perp | Initial Pass/Fail: Fail | Overall Compliance: No |
| Severity Score: 33.75 | | | |

Not Found, R304.5.1, R304.2.2, R304.5.3

| Compliance | Description | Data | Compliance | Description | Data |
|---|---|---|---|---|---|
| N/A | Ramp Length (in) | 98.0 | No | Ramp Slope (%) | 9.0 |
| No | Ramp Width (in) | 39.0 | No | Ramp XSlope (%) | 6.8 |

Remove & Replace Entire Ramp.
