Access Compliance Report Public Rights-of-Way (Curb Ramps)

•		-					
Intersection ID: 4017	tersection ID: 4017 Main Street: GALLOWAY_RD			treet:	KENDAN_KNOLL_DR	Location:	SE		
ADA ID: 9D215CFCDA6	ID: 9D215CFCDA6B Ramp Type: PerpDiag			Initial Pass/Fail: Fail Overall Compliance: No				o Severity Score:	37.5
Codes/Mitigation Info/Possible Solution				Field Measurements/Component Compliance

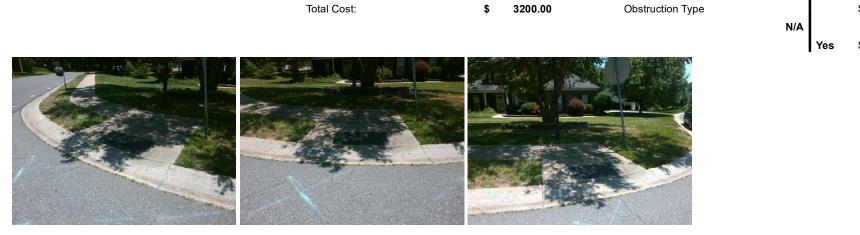
S. Y. S. Landa	Possible Solutions:						Compliance Description Data	
	1 Post	Remove & Replace Curb Ramp Wir Two New Directional Ramps or Equivalent.	Vith	N/A	Ramp Length (in)	49.0	No	Ramp Slope (%)	9.7
ALC ALCONT				Yes	Ramp Width (in)	48.0	No	Ramp XSlope (%)	7.2
All and the second				N/A	Flare Type LT	N/A	N/A	Flare Type RT	N/A
				N/A	Flare Slope LT (%)	N/A	N/A	Flare Slope RT (%)	N/A
the state of the s				N/A	Flare Traversable LT?	N/A	N/A	Flare Traversable RT?	N/A
ALLOW	IN RD			N/A	Landing Length (in)	N/A	N/A	DWS Provided?	N/A
Cha	300	Surveyor Notes:		N/A	Landing Width (in)	N/A	N/A	DWS Contrast?	N/A
	THE THERE THE	N/A		N/A	Landing Slope (%)	N/A	N/A	DWS Length (in)	N/A

6. B	and and a second			N/A	Landing X Slope (%)	N/A	N/A	DWS Full Width?	N/A
	And			N/A	Landing Curb? (Y/N)	N/A	N/A	DWS Offset (in)	N/A
	C C C C C C C C C C C C C C C C C C C			N/A	Shared Landing?	N/A			
		PROW/ADA:		N/A	Gutter Ponding?	N/A	N/A	Gutter Slope (%)	N/A
				N/A	Gutter Lip Ht (in)	N/A	N/A	Gutter X Slope (%)	N/A
		Not Found, R304.2.2, R304.5.3		N/A	Painted X Walk1?	No	N/A	Painted X Walk2?	N/A No
E C				IN/A	X Walk 1 Direction	To N	N/A	X Walk 2 Direction	To W
				N1/A		-	N/A		
				N/A	X Walk 1 Width (in)	N/A	N/A	X Walk 2 Width (in)	N/A
Street 1 Name	GALLOWAY RD				X Walk 1 Slope (%)	7.8		X Walk 2 Slope (%)	2.8
Stop Condition-Street 2	None				X Walk 1 X Slope (%)	3.2		X Walk 2 X Slope (%)	1.9
Street 2 Name	KENDALL KNOLL DR			N/A	Ramp inside XWalk1?	N/A		Ramp inside XWalk2?	N/A
Stop Condition-Street 1	StopSign				Road Slope (%)	2.6	N/A	Clear Space?	N/A
					Road X Slope (%)	4.1	N/A	Clear Space to XWalk (in)	N/A
