# Access Compliance Report

## Public Rights-of-Way

### (Curb Ramps)

Intersection ID: 53351	Main Street: MARVIN_RD	Cross Street: SAPPHIRE_HILL_LN	Location: SE
ADA ID: 9D2253CBC3F3	Ramp Type: Perp	Initial Pass/Fail: Fail	Overall Compliance: No
Severity Score: 22.5			
Codes/Mitigation Info/Possible Solution		Field Measurements/Component Compliance

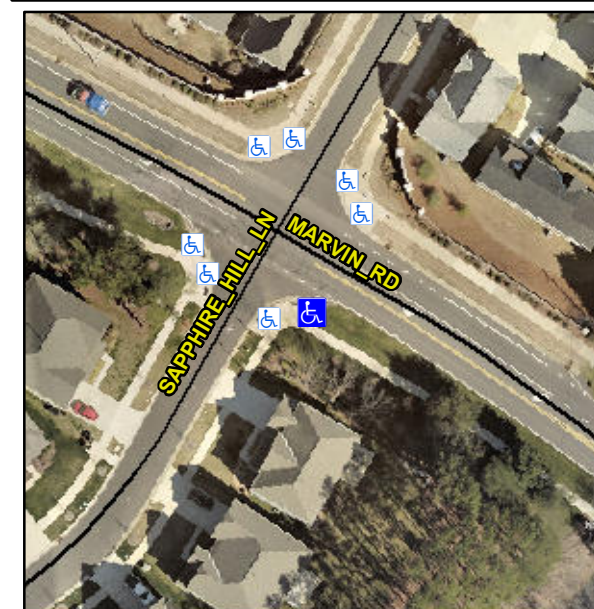
Compliance	Description	Data	Compliance	Description	Data
N/A	Ramp Length (in)	113.0	No	Ramp Slope (%)	11.2
No	Ramp Width (in)	46.5	No	Ramp XSlope (%)	4.3
N/A	Flare Type LT	N/A	N/A	Flare Type RT	N/A
N/A	Flare Slope LT (%)	N/A	N/A	Flare Slope RT (%)	N/A
N/A	Flare Traversable LT?	N/A	N/A	Flare Traversable RT?	N/A
N/A	Landing Length (in)	N/A	N/A	DWS Provided?	N/A
N/A	Landing Width (in)	N/A	N/A	DWS Contrast?	N/A
N/A	Landing Slope (%)	N/A	N/A	DWS Length (in)	N/A
N/A	Landing X Slope (%)	N/A	N/A	DWS Full Width?	N/A
N/A	Landing Curb? (Y/N)	N/A	N/A	DWS Offset (in)	N/A
N/A	Shared Landing?	N/A			
N/A	Gutter Ponding?	N/A	N/A	Gutter Slope (%)	N/A
N/A	Gutter Lip Ht (in)	N/A	N/A	Gutter X Slope (%)	N/A
N/A	Painted X Walk1?	No	N/A	Painted X Walk2?	N/A
	X Walk 1 Direction	To NE		X Walk 2 Direction	N/A
N/A	X Walk 1 Width (in)	N/A	N/A	X Walk 2 Width (in)	N/A
	X Walk 1 Slope (%)	2.8		X Walk 2 Slope (%)	N/A
	X Walk 1 X Slope (%)	3.7		X Walk 2 X Slope (%)	N/A

N/A	Ramp inside XWalk1?	N/A	N/A	Ramp inside XWalk2?	N/A
	Road Slope (%)	N/A	N/A	Clear Space?	N/A
	Road X Slope (%)	N/A	N/A	Clear Space to XWalk (in)	N/A
N/A	Any Obstructions?	N/A	N/A	Storm Grate/Utility Hazard?	N/A
	Obstruction Type			Storm Grate/Utility Type	
		N/A			N/A
			Yes	Surface Condition? (G/P)	Good

**Remove & Replace Entire Ramp.**

**R304.5.1, R304.2.2, R304.5.3**
