## **Access Compliance Report Public Rights-of-Way** (Curb Ramps)

Intersection ID: 10041619 Main Street: WHITEHALL\_COMMONS\_CENTERosDIStreet: N/A Location: SW

ADA ID: 9D272AC3568A Ramp Type: Perp Initial Pass/Fail: Fail **Overall Compliance: No** Severity Score: 21.25

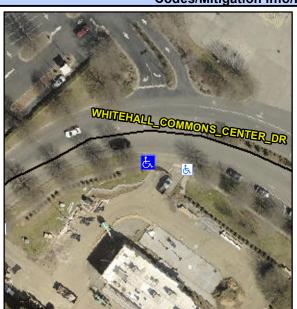
**ENTRANCE** Street 1 Name Stop Condition-Street 2 StopSign Street 2 Name N/A Stop Condition-Street 1 N/A

Field Measurements/Component Compliance									
Comp	liance Description	Data	Comp	liance Description	Data				
N/A	Ramp Length (in)	76.5	No	Ramp Slope (%)	10.2				
No	Ramp Width (in)	47.0	Yes	Ramp XSlope (%)	2.0				
N/A	Flare Type LT	N/A	N/A	Flare Type RT	N/A				
N/A	Flare Slope LT (%)	N/A	N/A	Flare Slope RT (%)	N/A				
N/A	Flare Traversable LT?	N/A	N/A	Flare Traversable RT?	N/A				
N/A	Landing Length (in)	N/A	N/A	DWS Provided?	N/A				
N/A	Landing Width (in)	N/A	N/A	DWS Contrast?	N/A				
N/A	Landing Slope (%)	N/A	N/A	DWS Length (in)	N/A				
N/A	Landing X Slope (%)	N/A	N/A	DWS Full Width?	N/A				
N/A	Landing Curb? (Y/N)	N/A	N/A	DWS Offset (in)	N/A				
N/A	Shared Landing?	N/A							
N/A	Gutter Ponding?	N/A	N/A	Gutter Slope (%)	N/A				
N/A	Gutter Lip Ht (in)	N/A	N/A	Gutter X Slope (%)	N/A				
N/A	Painted X Walk1?	No	N/A	Painted X Walk2?	N/A				
	X Walk 1 Direction	To E		X Walk 2 Direction	N/A				
N/A	X Walk 1 Width (in)	N/A	N/A	X Walk 2 Width (in)	N/A

X Walk 1 Slope (%)	5.1		X Walk 2 Slope (%)	N/A				
	X Walk 1 X Slope (%)	2.3		X Walk 2 X Slope (%)	N/A				
N/A	Ramp inside XWalk1?	N/A	N/A	Ramp inside XWalk2?	N/A				
	Road Slope (%)	N/A	N/A	Clear Space?	N/A				
	Road X Slope (%)	N/A	N/A	Clear Space to XWalk (in)	N/A				
N/A	Any Obstructions?	N/A	N/A	Storm Grate/Utility Hazard?	N/A				
	Obstruction Type			Storm Grate/Utility Type

11.0	Possible Solutions:						
ì	Remove & Replace Entire Ramp.						
ı							
ì							
-							
į							
,	Surveyor Notes:						
q	N/A						
4							
S A	PROW/ADA:						
	Not Found, R304.5.1, R304.2.2						
	110t 1 cana, 11004.5.1, 11004.2.2						
4							
1

Total Cost:	\$	1850.00
