# Access Compliance Report

## Public Rights-of-Way

### (Curb Ramps)

Intersection ID: 3776	Main Street: CANTLE_DR	Cross Street: NETTLE_DR	Location:	SE
ADA ID: 9D2BE66C7809	Ramp Type: Perp	Initial Pass/Fail: Pass	Overall Compliance: No	Severity Score: 10
Codes/Mitigation Info/Possible Solution		Field Measurements/Component Compliance

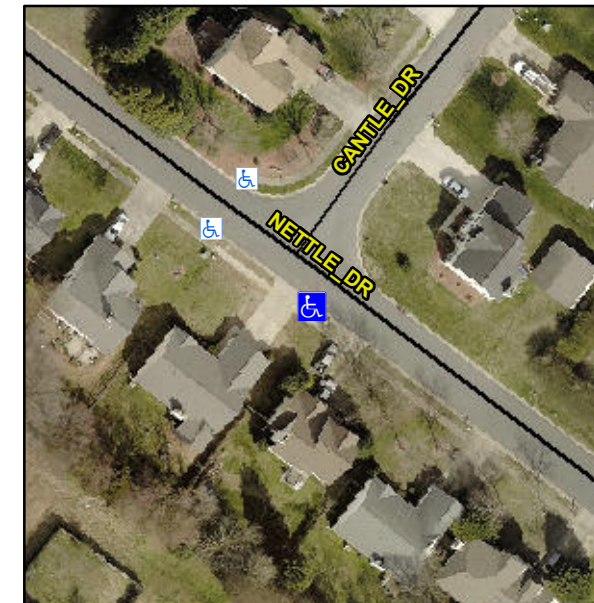
**Not Found, R304.2.1, R305**

Compliance	Description	Data	Compliance	Description	Data
N/A	Ramp Length (in)	49.0	Yes	Ramp Slope (%)	6.1
Yes	Ramp Width (in)	48.0	Yes	Ramp XSlope (%)	1.6
N/A	Flare Type LT	None	N/A	Flare Type RT	N/A
N/A	Flare Slope LT (%)	N/A	N/A	Flare Slope RT (%)	N/A
N/A	Flare Traversable LT?	N/A	N/A	Flare Traversable RT?	N/A
No	Landing Length (in)	45.5	No	DWS Provided?	No
Yes	Landing Width (in)	48.0	N/A	DWS Contrast?	No
Yes	Landing Slope (%)	0.0	N/A	DWS Length (in)	N/A
Yes	Landing X Slope (%)	2.0	N/A	DWS Full Width?	No
N/A	Landing Curb? (Y/N)	No	N/A	DWS Offset (in)	N/A
N/A	Shared Landing?	No			
Yes	Gutter Ponding?	No	Yes	Gutter Slope (%)	1.6
Yes	Gutter Lip Ht (in)	0.0	Yes	Gutter X Slope (%)	1.5
N/A	Painted X Walk1?	No	N/A	Painted X Walk2?	N/A
	X Walk 1 Direction	To E		X Walk 2 Direction	N/A
N/A	X Walk 1 Width (in)	N/A	N/A	X Walk 2 Width (in)	N/A
	X Walk 1 Slope (%)	3.1		X Walk 2 Slope (%)	N/A
	X Walk 1 X Slope (%)	2.1		X Walk 2 X Slope (%)	N/A

N/A	Ramp inside XWalk1?	N/A	N/A	Ramp inside XWalk2?	N/A
	Road Slope (%)	N/A	N/A	Clear Space?	Yes
	Road X Slope (%)	N/A	N/A	Clear Space to XWalk (in)	N/A
Yes	Any Obstructions?	No	Yes	Storm Grate/Utility Hazard?	No
	Obstruction Type			Storm Grate/Utility Type	
			N/A		N/A
			Yes	Surface Condition? (G/P)	Good

**Remove & Replace Entire Ramp.**
