# Access Compliance Report

## Public Rights-of-Way

### (Curb Ramps)

Intersection ID: 4883	Main Street: HEDGECREST_PL	Cross Street: MARIONWOOD_DR	Location:	S
ADA ID: 9D39BC9D9096	Ramp Type: Perp	Initial Pass/Fail: Fail	Overall Compliance: No	Severity Score: 37.5

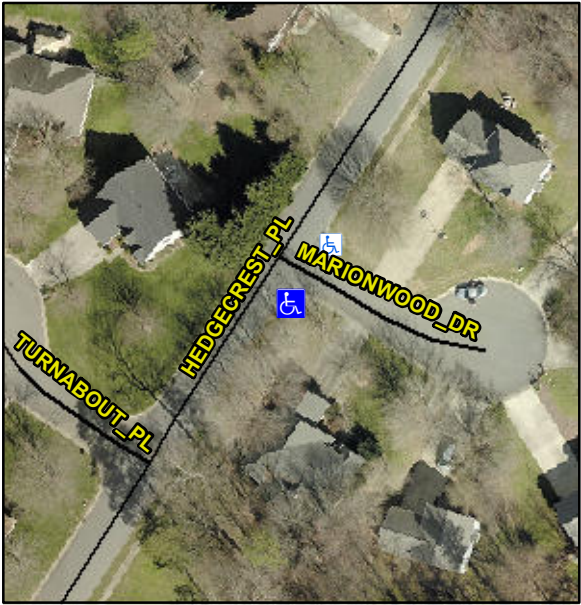
Possible Solutions:	<b>Remove &amp; Replace Entire Ramp.</b>					
	Surveyor Notes:	N/A					
	PROW/ADA:	Not Found, R304.2.2, R304.5.3					
	Street 1 Name	MARIONWOOD DR					
	Stop Condition-Street 2	StopSign					
	Street 2 Name	N/A					
	Stop Condition-Street 1	N/A					
	Total Cost:	\$ 1850.00					
		Compliance	Description	Data	Compliance	Description	Data
		N/A	Ramp Length (in)	48.0	No	Ramp Slope (%)	8.6
		Yes	Ramp Width (in)	48.0	No	Ramp XSlope (%)	7.8
		N/A	Flare Type LT	N/A	N/A	Flare Type RT	N/A
		N/A	Flare Slope LT (%)	N/A	N/A	Flare Slope RT (%)	N/A
		N/A	Flare Traversable LT?	N/A	N/A	Flare Traversable RT?	N/A
		N/A	Landing Length (in)	N/A	N/A	DWS Provided?	N/A
		N/A	Landing Width (in)	N/A	N/A	DWS Contrast?	N/A
		N/A	Landing Slope (%)	N/A	N/A	DWS Length (in)	N/A
		N/A	Landing X Slope (%)	N/A	N/A	DWS Full Width?	N/A
		N/A	Landing Curb? (Y/N)	N/A	N/A	DWS Offset (in)	N/A

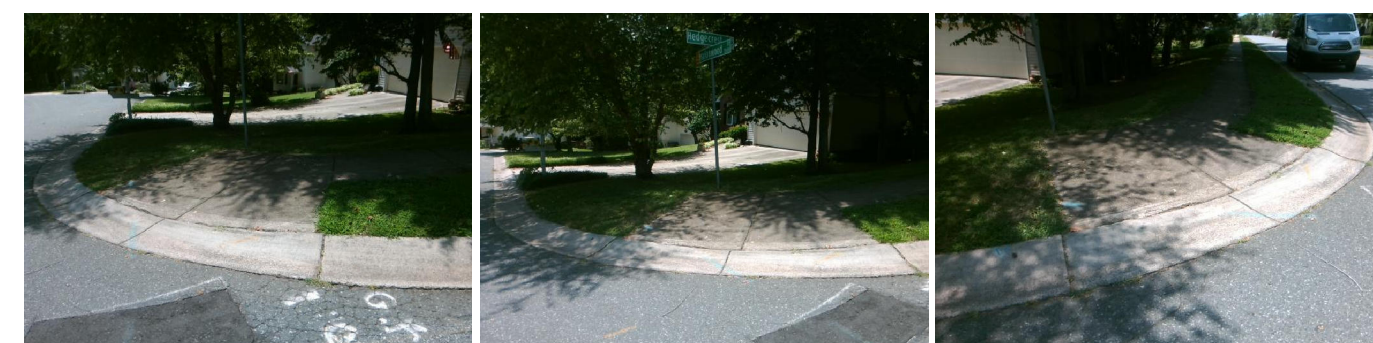
N/A	Shared Landing?	N/A			
		N/A	Gutter Ponding?	N/A	N/A	Gutter Slope (%)	N/A
		N/A	Gutter Lip Ht (in)	N/A	N/A	Gutter X Slope (%)	N/A
		N/A	Painted X Walk1?	No	N/A	Painted X Walk2?	N/A
			X Walk 1 Direction	To NE		X Walk 2 Direction	N/A
		N/A	X Walk 1 Width (in)	N/A	N/A	X Walk 2 Width (in)	N/A
			X Walk 1 Slope (%)	1.6		X Walk 2 Slope (%)	N/A
			X Walk 1 X Slope (%)	7.1		X Walk 2 X Slope (%)	N/A
		N/A	Ramp inside XWalk1?	N/A	N/A	Ramp inside XWalk2?	N/A
			Road Slope (%)	N/A	N/A	Clear Space?	N/A
			Road X Slope (%)	N/A	N/A	Clear Space to XWalk (in)	N/A
		N/A	Any Obstructions?	N/A	N/A	Storm Grate/Utility Hazard?	N/A
			Obstruction Type			Storm Grate/Utility Type	
				N/A			N/A
					Yes	Surface Condition? (G/P)	Good
