Access Compliance Report

Public Rights-of-Way

(Curb Ramps)

Intersection ID: 3069	Main Street: HEDGE_MAPLE_RD	Cross Street: HARTINGTON_PL	Location: NE
ADA ID: 9D3D575D2131	Ramp Type: Perp	Initial Pass/Fail: Fail	Overall Compliance: No
Severity Score: 10			
Codes/Mitigation Info/Possible Solution		Field Measurements/Component Compliance

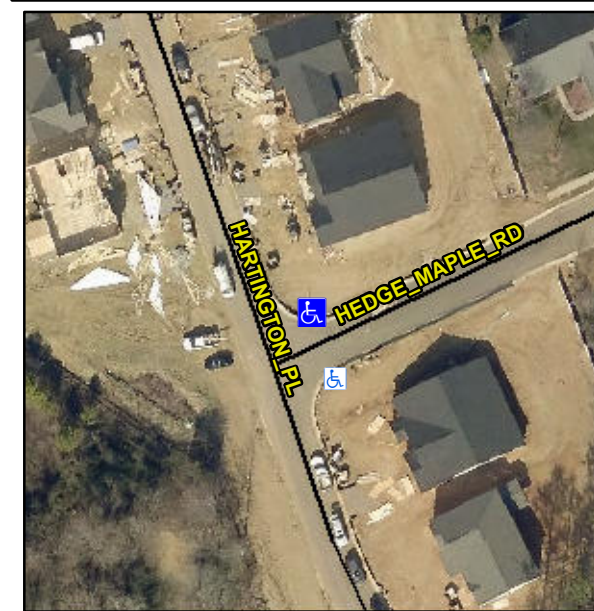
Not Found, R304.5.1, R304.5.3

Compliance	Description	Data	Compliance	Description	Data
N/A	Ramp Length (in)	48.0	Yes	Ramp Slope (%)	6.0
No	Ramp Width (in)	47.0	No	Ramp XSlope (%)	3.0
N/A	Flare Type LT	N/A	N/A	Flare Type RT	N/A
N/A	Flare Slope LT (%)	N/A	N/A	Flare Slope RT (%)	N/A
N/A	Flare Traversable LT?	N/A	N/A	Flare Traversable RT?	N/A
N/A	Landing Length (in)	N/A	N/A	DWS Provided?	N/A
N/A	Landing Width (in)	N/A	N/A	DWS Contrast?	N/A
N/A	Landing Slope (%)	N/A	N/A	DWS Length (in)	N/A
N/A	Landing X Slope (%)	N/A	N/A	DWS Full Width?	N/A
N/A	Landing Curb? (Y/N)	N/A	N/A	DWS Offset (in)	N/A
N/A	Shared Landing?	N/A			
N/A	Gutter Ponding?	N/A	N/A	Gutter Slope (%)	N/A
N/A	Gutter Lip Ht (in)	1.0	N/A	Gutter X Slope (%)	N/A
N/A	Painted X Walk1?	No	N/A	Painted X Walk2?	N/A
	X Walk 1 Direction	To S		X Walk 2 Direction	N/A
N/A	X Walk 1 Width (in)	N/A	N/A	X Walk 2 Width (in)	N/A
	X Walk 1 Slope (%)	0.8		X Walk 2 Slope (%)	N/A
	X Walk 1 X Slope (%)	5.4		X Walk 2 X Slope (%)	N/A

N/A	Ramp inside XWalk1?	N/A	N/A	Ramp inside XWalk2?	N/A
	Road Slope (%)	N/A	N/A	Clear Space?	N/A
	Road X Slope (%)	N/A	N/A	Clear Space to XWalk (in)	N/A
N/A	Any Obstructions?	N/A	N/A	Storm Grate/Utility Hazard?	N/A
	Obstruction Type			Storm Grate/Utility Type	
		N/A			N/A
			Yes	Surface Condition? (G/P)	Good

Remove & Replace Entire Ramp.
