Access Compliance Report

Public Rights-of-Way

(Curb Ramps)

| Intersection ID: 23481 | Main Street: ALEXANDER_RD | Cross Street: PROVIDENCE_RD | Location: SW |

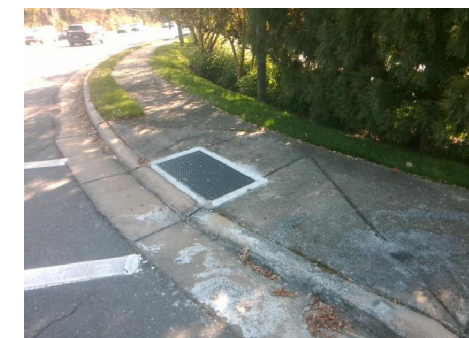
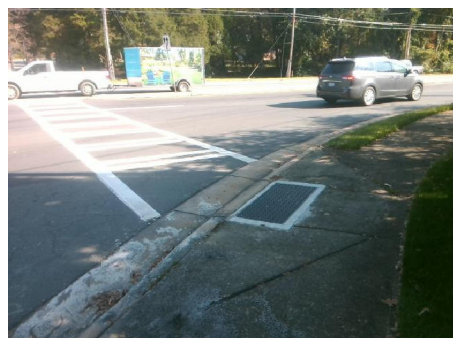
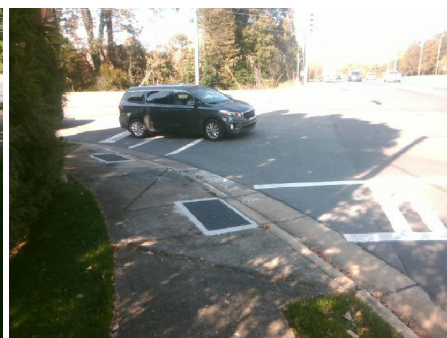
| ADA ID: 9D47339C76EB | Ramp Type: Perp | Initial Pass/Fail: Fail | Overall Compliance: No |

Not Found, R304.5.1, R304.5.3

| Compliance | Description | Data | Compliance | Description | Data |
|---|---|---|---|---|---|
| No | Ramp Width (in) | 44.0 | No | Ramp XSlope (%) | 2.8 |

Remove & Replace Entire Ramp.
