Access Compliance Report

Public Rights-of-Way

(Curb Ramps)

| Intersection ID: 53062 | Main Street: PAVILION_VILLAGE_DR | Cross Street: N/A | Location: N |

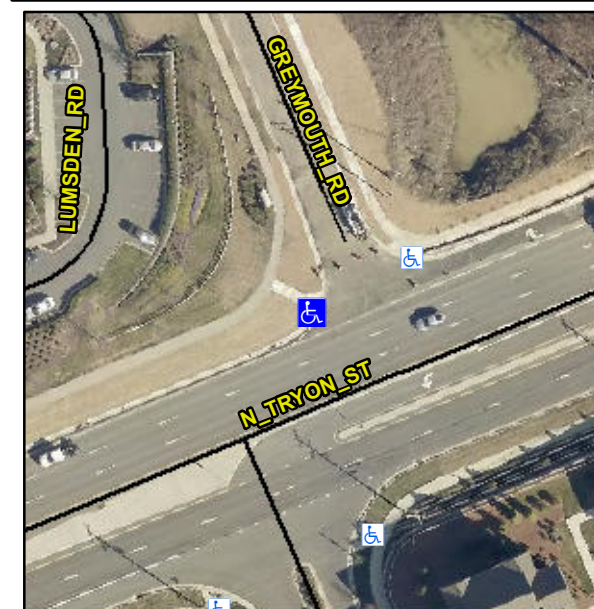
| ADA ID: 9D481CD88832 | Ramp Type: Perp | Initial Pass/Fail: Fail | Overall Compliance: No |
| Severity Score: 1.25 | | | |

Not Found, R304.5.3

| Compliance | Description | Data | Compliance | Description | Data |
|---|---|---|---|---|---|
| Yes | Ramp Width (in) | 48.0 | No | Ramp XSlope (%) | 3.6 |

Possible Solutions:

Remove & Replace Entire Ramp.

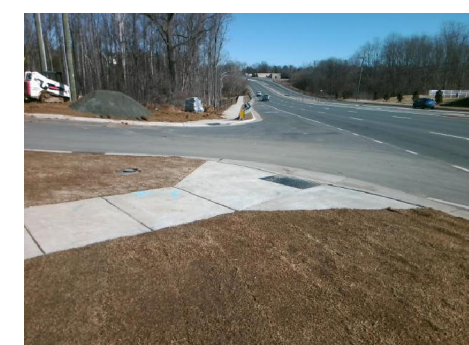
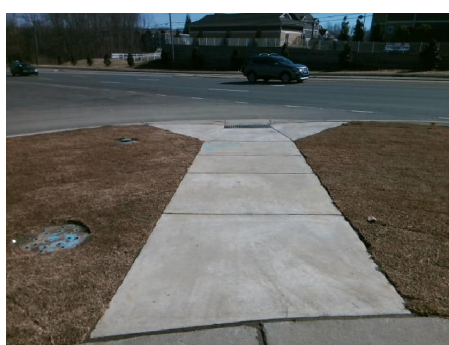
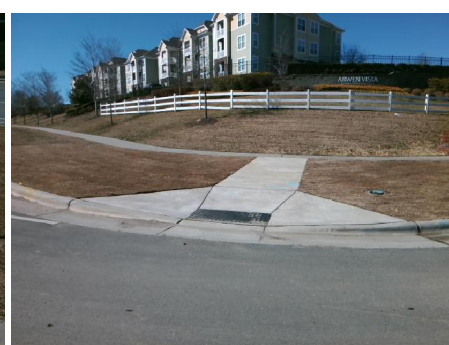
| Compliance | Description | Data | Compliance | Description | Data |
|---|---|---|---|---|---|
| N/A | Ramp Length (in) | 97.5 | Yes | Ramp Slope (%) | 7.7 |
| | | Yes | | Surface Condition? (G/P) | Good |
