Intersection ID: 1003042	Main Street: AMBER_MEADOWS_DR	Cross Street: GLENOLDEN_DR	Location:	NW
ADA ID: 9D58EBD66755	Ramp Type: Perp	Initial Pass/Fail: Fail	Overall Compliance: No	Severity Score: 21.25

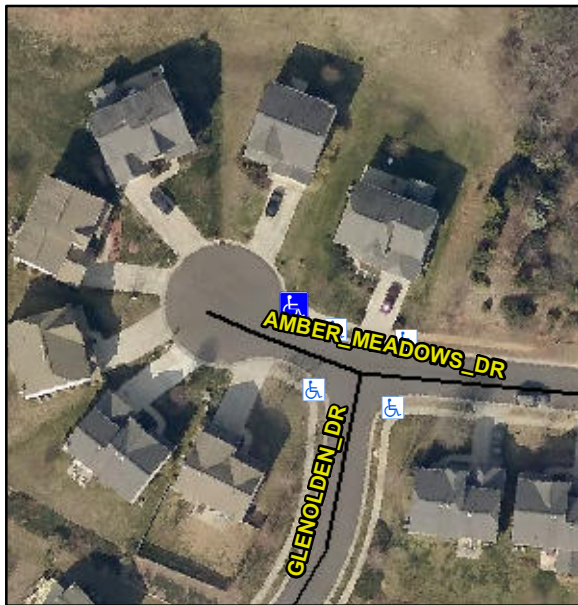
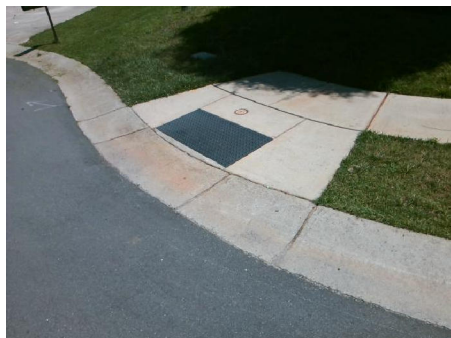
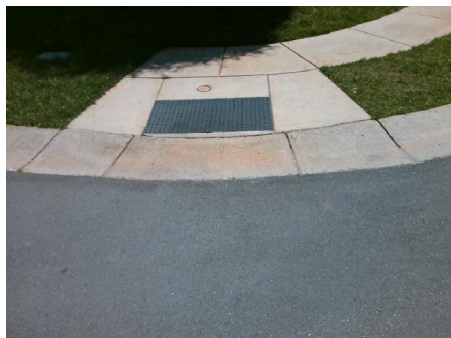
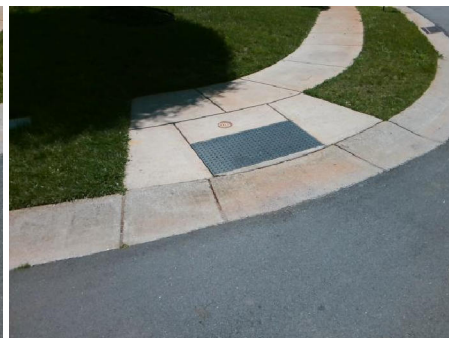
Not Found, R304.5.1, R304.2.2

Possible Solutions:			Compliance	Description	Data	Compliance	Description	Data
Remove & Replace Entire Ramp.			N/A	Ramp Length (in)	47.0	No	Ramp Slope (%)	9.3
			No	Ramp Width (in)	47.0	Yes	Ramp XSlope (%)	1.0
			N/A	Flare Type LT	N/A	N/A	Flare Type RT	N/A
			N/A	Flare Slope LT (%)	N/A	N/A	Flare Slope RT (%)	N/A
			N/A	Flare Traversable LT?	N/A	N/A	Flare Traversable RT?	N/A
			N/A	Landing Length (in)	N/A	N/A	DWS Provided?	N/A
			N/A	Landing Width (in)	N/A	N/A	DWS Contrast?	N/A
			N/A	Landing Slope (%)	N/A	N/A	DWS Length (in)	N/A
			N/A	Landing X Slope (%)	N/A	N/A	DWS Full Width?	N/A
			N/A	Landing Curb? (Y/N)	N/A	N/A	DWS Offset (in)	N/A
Surveyor Notes:			N/A	Shared Landing?	N/A			
Not Found, R304.5.1, R304.2.2			N/A	Gutter Ponding?	N/A	N/A	Gutter Slope (%)	N/A
			N/A	Gutter Lip Ht (in)	N/A	N/A	Gutter X Slope (%)	N/A
			N/A	Painted X Walk1?	No	N/A	Painted X Walk2?	N/A
				X Walk 1 Direction	To SW		X Walk 2 Direction	N/A

N/A	X Walk 1 Width (in)	N/A	N/A	X Walk 2 Width (in)	N/A
				X Walk 1 Slope (%)	2.2		X Walk 2 Slope (%)	N/A
				X Walk 1 X Slope (%)	0.2		X Walk 2 X Slope (%)	N/A
			N/A	Ramp inside XWalk1?	N/A	N/A	Ramp inside XWalk2?	N/A
				Road Slope (%)	N/A	N/A	Clear Space?	N/A
				Road X Slope (%)	N/A	N/A	Clear Space to XWalk (in)	N/A
Total Cost: \$ 1850.00			N/A	Any Obstructions?	N/A	N/A	Storm Grate/Utility Hazard?	N/A
				Obstruction Type			Storm Grate/Utility Type	
					N/A			N/A
						Yes	Surface Condition? (G/P)	Good

Remove & Replace Entire Ramp.

Total Cost: \$ 1850.00
