Access Compliance Report

Public Rights-of-Way

(Curb Ramps)

Intersection ID: 49386	Main Street: DAMASCUS_ST	Cross Street: SOUTH_DEVON_ST	Location: SE
ADA ID: 9D63752C5CA9	Ramp Type: Perp	Initial Pass/Fail: Fail	Overall Compliance: No
			Severity Score: 13.75

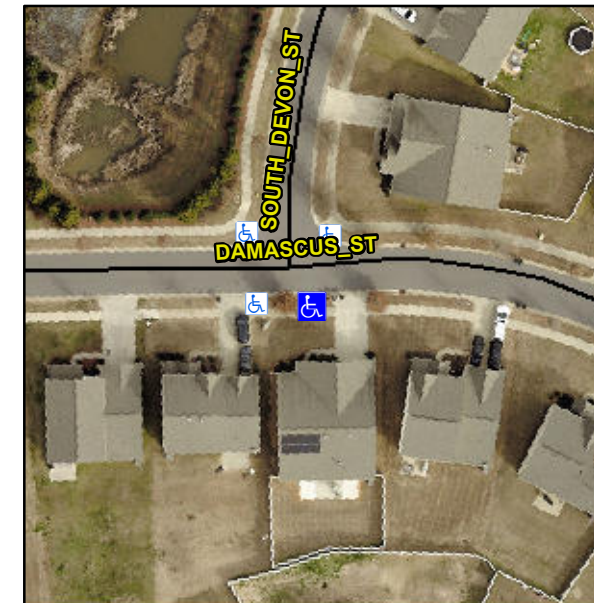
Not Found, R304.2.2

Compliance	Description	Data	Compliance	Description	Data
N/A	Ramp Length (in)	71.0	No	Ramp Slope (%)	8.6
Yes	Ramp Width (in)	48.0	Yes	Ramp XSlope (%)	3.4
N/A	Flare Type LT	N/A	N/A	Flare Type RT	N/A
N/A	Flare Slope LT (%)	N/A	N/A	Flare Slope RT (%)	N/A
N/A	Flare Traversable LT?	N/A	N/A	Flare Traversable RT?	N/A
N/A	Landing Length (in)	N/A	N/A	DWS Provided?	N/A
N/A	Landing Width (in)	N/A	N/A	DWS Contrast?	N/A
N/A	Landing Slope (%)	N/A	N/A	DWS Length (in)	N/A
N/A	Landing X Slope (%)	N/A	N/A	DWS Full Width?	N/A
N/A	Landing Curb? (Y/N)	N/A	N/A	DWS Offset (in)	N/A
N/A	Shared Landing?	N/A			
N/A	Gutter Ponding?	N/A	N/A	Gutter Slope (%)	N/A
N/A	Gutter Lip Ht (in)	0.5	N/A	Gutter X Slope (%)	N/A
N/A	Painted X Walk1?	No	N/A	Painted X Walk2?	N/A
	X Walk 1 Direction	To NE		X Walk 2 Direction	N/A
N/A	X Walk 1 Width (in)	N/A	N/A	X Walk 2 Width (in)	N/A
	X Walk 1 Slope (%)	4.2		X Walk 2 Slope (%)	N/A
	X Walk 1 X Slope (%)	3.5		X Walk 2 X Slope (%)	N/A

N/A	Ramp inside XWalk1?	N/A	N/A	Ramp inside XWalk2?	N/A
	Road Slope (%)	N/A	N/A	Clear Space?	N/A
	Road X Slope (%)	N/A	N/A	Clear Space to XWalk (in)	N/A
N/A	Any Obstructions?	N/A	N/A	Storm Grate/Utility Hazard?	N/A
	Obstruction Type			Storm Grate/Utility Type	
		N/A			N/A
			Yes	Surface Condition? (G/P)	Good

Remove & Replace Entire Ramp.
