Access Compliance Report

Public Rights-of-Way

(Curb Ramps)

Intersection ID: 13518		Main Street: COMMONWEALTH_AV		Cross Street: ST_JULIEN_ST		Location: W									
ADA ID: 9D72FFFA01E3		Ramp Type: Directional1		Initial Pass/Fail: Pass		Overall Compliance: Yes		Severity Score: 0							
Codes/Mitigation Info/Possible Solution				Field Measurements/Component Compliance											
<div>

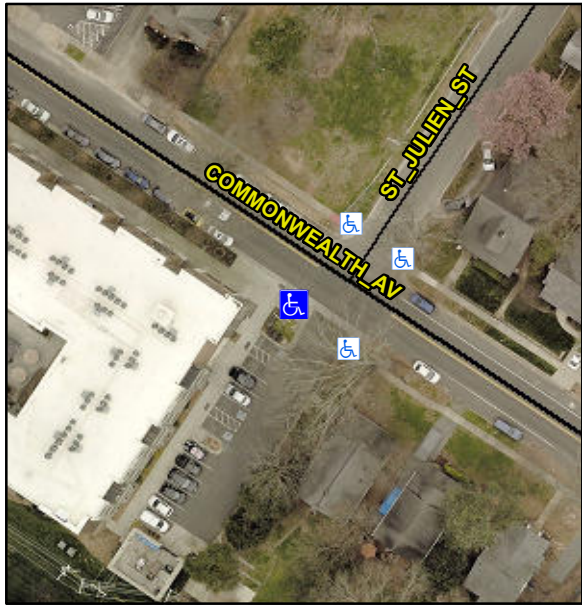
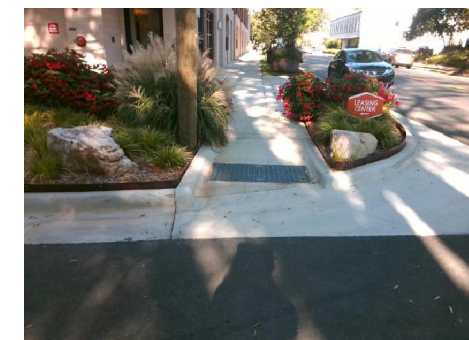
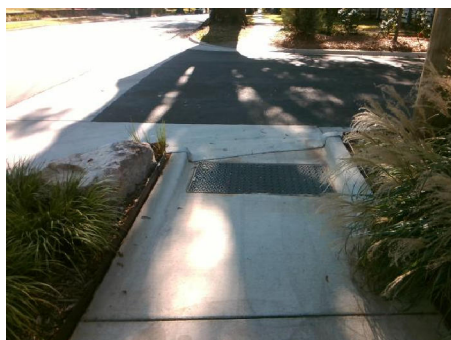
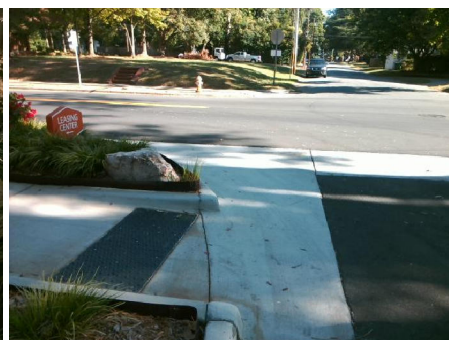
</div> <div>Street 1 NameST JULIEN ST</div> <div>Stop Condition-Street 1None</div> <div>Street 2 NameN/A</div> <div>Stop Condition-Street 2N/A</div>				Possible Solutions:		N/A									
				Surveyor Notes:		N/A									
				PROW/ADA:		N/A									
				Total Cost:		\$ 0.00									
				Compliance		Description		Data		Compliance		Description		Data	
				N/A		Ramp Length (in)		75.5		Yes		Grade Break?		Yes	
				Yes		Ramp Width (in)		50.0		Yes		Grade Break Slope (%)		1.9	
				Yes		Ramp Slope (%)		3.1		Yes		Grade Break XSlope (%)		1.4	
				Yes		Ramp XSlope (%)		0.5							
				Yes		Flare Type LT		N/A		Yes		Flare Type RT		N/A

N/A		Flare Slope LT (%)		N/A		N/A		Flare Slope RT (%)		N/A					
N/A		Flare Traversable LT?		No		N/A		Flare Traversable RT?		No					
Yes		Landing Length (in)		94.0		Yes		DWS Provided?		Yes					
Yes		Landing Width (in)		68.0		Yes		DWS Contrast?		Yes					
Yes		Landing Slope (%)		1.1		Yes		DWS Length (in)		24.0					
Yes		Landing X Slope (%)		0.3		Yes		DWS Full Width?		Yes					
N/A		Landing Curb? (Y/N)		No		Yes		DWS Offset LT (in)		17.0					
N/A		Shared Landing?		No		Yes		DWS Offset RT (in)		1.5					
Yes		Gutter Ponding?		No		Yes		Gutter Slope (%)		0.2					
Yes		Gutter Lip Ht (in)		0.0		Yes		Gutter X Slope (%)		1.5					
N/A		Painted X Walk1?		No				Road Slope (%)		3.5					
		X Walk 1 Direction		To SE				Road X Slope (%)		1.7					
		X Walk 1 Width (in)		N/A				Clear Space?		Yes					
		X Walk 1 Slope (%)		3.5		N/A		Clear Space to XWalk (in)		N/A					
		X Walk 1 X Slope (%)		1.7		Yes		Storm Grate/Utility Hazard?		No

N/A		Ramp inside XWalk1?		N/A				Storm Grate/Utility Type							
Yes		Any Obstructions?		No						N/A					
		Obstruction Type				Yes		Surface Condition? (G/P)		Good					
						N/A		Yes		Curb Slope (%)		2.2
