Access Compliance Report

Public Rights-of-Way

(Curb Ramps)

Intersection ID: 10156	Main Street: BEATTIES_FORD_RD	Cross Street: MILL_RD	Location: NW
ADA ID: 9D7B0A0E2402	Ramp Type: PerpDiag	Initial Pass/Fail: Fail	Overall Compliance: No
Codes/Mitigation Info/Possible Solution		Field Measurements/Component Compliance	
Severity Score: 46.25

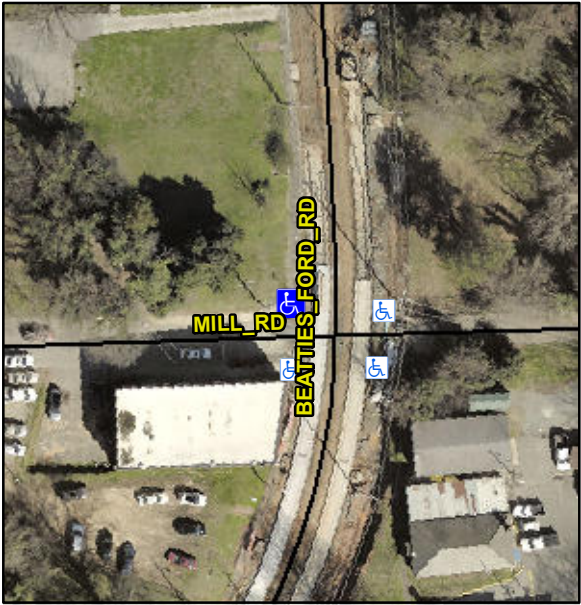
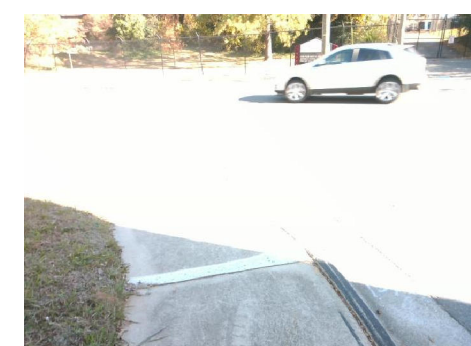
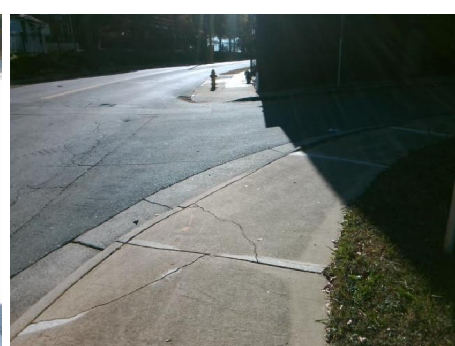
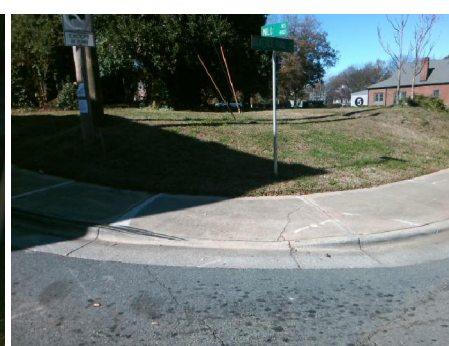
Possible Solutions:	Compliance	Description	Data	Compliance	Description	Data
	Remove & Replace Curb Ramp With Two New Directional Ramps or Equivalent.	N/A	Ramp Length (in)	68.0	No	Ramp Slope (%)	9.3
<p>Surveyor Notes:</p> <p>N/A</p> <p>PROW/ADA:</p> <p>Not Found, R304.5.1, R304.2.2, R304.5.3</p>		No	Ramp Width (in)	43.0	No	Ramp XSlope (%)	7.4
		N/A	Flare Type LT	N/A	N/A	Flare Type RT	N/A
		N/A	Flare Slope LT (%)	N/A	N/A	Flare Slope RT (%)	N/A
		N/A	Flare Traversable LT?	N/A	N/A	Flare Traversable RT?	N/A
		N/A	Landing Length (in)	N/A	N/A	DWS Provided?	N/A
		N/A	Landing Width (in)	N/A	N/A	DWS Contrast?	N/A
		N/A	Landing Slope (%)	N/A	N/A	DWS Length (in)	N/A
		N/A	Landing X Slope (%)	N/A	N/A	DWS Full Width?	N/A
		N/A	Landing Curb? (Y/N)	N/A	N/A	DWS Offset (in)	N/A
		N/A	Shared Landing?	N/A			
		N/A	Gutter Ponding?	N/A	N/A	Gutter Slope (%)	N/A
		N/A	Gutter Lip Ht (in)	N/A	N/A	Gutter X Slope (%)	N/A
		N/A	Painted X Walk1?	No	N/A	Painted X Walk2?	No

X Walk 1 Direction	To S		X Walk 2 Direction	To E
		N/A	X Walk 1 Width (in)	N/A	N/A	X Walk 2 Width (in)	N/A
			X Walk 1 Slope (%)	1.0		X Walk 2 Slope (%)	2.9
			X Walk 1 X Slope (%)	5.2		X Walk 2 X Slope (%)	5.1
		N/A	Ramp inside XWalk1?	N/A	N/A	Ramp inside XWalk2?	N/A
			Road Slope (%)	5.6	N/A	Clear Space?	N/A
			Road X Slope (%)	4.4	N/A	Clear Space to XWalk (in)	N/A
		N/A	Any Obstructions?	N/A	N/A	Storm Grate/Utility Hazard?	N/A
			Obstruction Type			Storm Grate/Utility Type	
				N/A			N/A
					Yes	Surface Condition? (G/P)	Good
Total Cost:		\$ 3200.00
