Access Compliance Report

Public Rights-of-Way

(Curb Ramps)

Intersection ID: 44778	Main Street: SILVER_CRESCENT_DR	Cross Street: VENDOME_ST	Location:	N
ADA ID: 9D7DE13F9688	Ramp Type: Directional1	Initial Pass/Fail: Fail	Overall Compliance: No	Severity Score: 1.25
Codes/Mitigation Info/Possible Solution		Field Measurements/Component Compliance

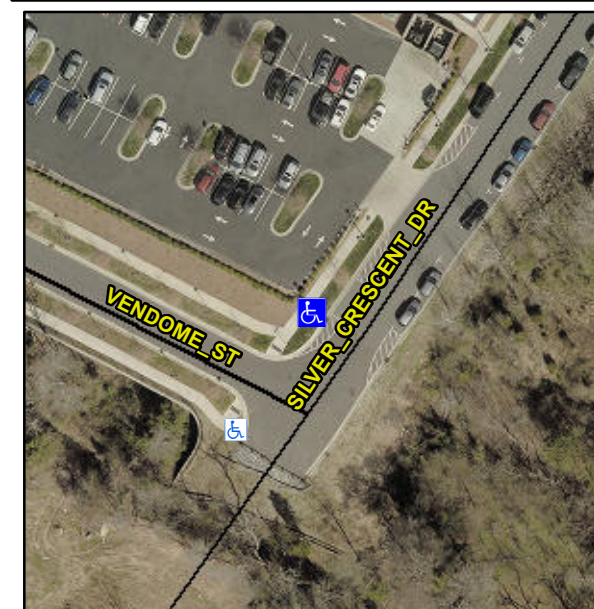
Compliance	Description	Data	Compliance	Description	Data
N/A	Ramp Length (in)	93.0	N/A	Grade Break?	N/A
Yes	Ramp Width (in)	70.0	N/A	Grade Break Slope (%)	0.0
Yes	Ramp Slope (%)	6.1	N/A	Grade Break XSlope (%)	0.0
No	Ramp XSlope (%)	2.9			
N/A	Flare Type LT	N/A	N/A	Flare Type RT	N/A
N/A	Flare Slope LT (%)	N/A	N/A	Flare Slope RT (%)	0.0
N/A	Flare Traversable LT?	N/A	N/A	Flare Traversable RT?	N/A
N/A	Landing Length (in)	0.0	N/A	DWS Provided?	N/A
N/A	Landing Width (in)	0.0	N/A	DWS Contrast?	N/A
N/A	Landing Slope (%)	0.0	N/A	DWS Length (in)	N/A
N/A	Landing X Slope (%)	0.0	N/A	DWS Full Width?	N/A
N/A	Landing Curb? (Y/N)	N/A	N/A	DWS Offset LT (in)	N/A
N/A	Shared Landing?	N/A	N/A	DWS Offset RT (in)	N/A
N/A	Gutter Ponding?	0.0	N/A	Gutter Slope (%)	N/A
N/A	Gutter Lip Ht (in)	0.0	N/A	Gutter X Slope (%)	N/A
N/A	Painted X Walk1?	No		Road Slope (%)	1.0
	X Walk 1 Direction	To SW		Road X Slope (%)	1.5
	X Walk 1 Width (in)	N/A		Clear Space?	N/A

X Walk 1 Slope (%)	1.0	N/A	Clear Space to XWalk (in)	N/A
	X Walk 1 X Slope (%)	1.5	N/A	Storm Grate/Utility Hazard?	N/A
N/A	Ramp inside XWalk1?	N/A		Storm Grate/Utility Type	
N/A	Any Obstructions?	N/A			N/A
	Obstruction Type		Yes	Surface Condition? (G/P)	Good
			N/A	Curb Slope (%)	11.9

Possible Solutions:

Remove & Replace Entire Ramp.

R304.5.3

\$ 1600.00
