## **Access Compliance Report Public Rights-of-Way** (Curb Ramps)

Intersection ID: 29916 Main Street: NORTHRIDGE DR **Cross Street: WILDBROOK DR** Location: ADA ID: 9D88317B66AB Ramp Type: PerpDiag Initial Pass/Fail: Fail **Overall Compliance: No** Severity Score: 21.25

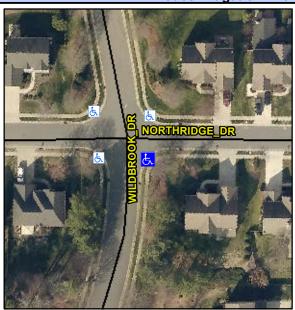
| Field Measurements/Component Compliance | | | | | | |
|---|---|---|---|---|---|--|
| N/A | Ramp Length (in) | 48.0 | Yes | Ramp Slope (%) | 6.9 | |
| No | Ramp Width (in) | 40.0 | No | Ramp XSlope (%) | 5.2 | |

Remove & Replace Curb Ramp With Two New Directional Ramps or Equivalent.

R304.5.1, R304.5.3
