# Access Compliance Report

## Public Rights-of-Way

### (Curb Ramps)

Intersection ID: 12804	Main Street: GLENSTAR_TR	Cross Street: SEAFORTH_DR	Location: S
ADA ID: 9D949046F13A	Ramp Type: PerpDiag	Initial Pass/Fail: Fail	Overall Compliance: No
Codes/Mitigation Info/Possible Solution		Field Measurements/Component Compliance	
Severity Score: 10

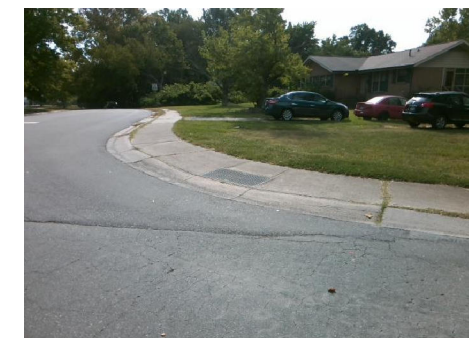
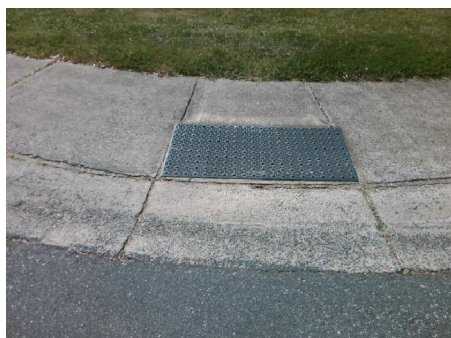
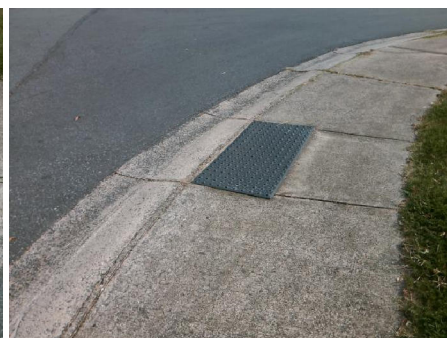
**Not Found, R304.5.1, R304.5.3**

Compliance	Description	Data	Compliance	Description	Data
N/A	Ramp Length (in)	59.0	Yes	Ramp Slope (%)	5.7
No	Ramp Width (in)	39.0	No	Ramp XSlope (%)	3.7
N/A	Flare Type LT	N/A	N/A	Flare Type RT	N/A
N/A	Flare Slope LT (%)	N/A	N/A	Flare Slope RT (%)	N/A
N/A	Flare Traversable LT?	N/A	N/A	Flare Traversable RT?	N/A
N/A	Landing Length (in)	N/A	N/A	DWS Provided?	N/A
N/A	Landing Width (in)	N/A	N/A	DWS Contrast?	N/A
N/A	Landing Slope (%)	N/A	N/A	DWS Length (in)	N/A
N/A	Landing X Slope (%)	N/A	N/A	DWS Full Width?	N/A
N/A	Landing Curb? (Y/N)	N/A	N/A	DWS Offset (in)	N/A
N/A	Shared Landing?	N/A			
N/A	Gutter Ponding?	N/A	N/A	Gutter Slope (%)	N/A
N/A	Gutter Lip Ht (in)	N/A	N/A	Gutter X Slope (%)	N/A
N/A	Painted X Walk1?	No	N/A	Painted X Walk2?	No
	X Walk 1 Direction	To NE		X Walk 2 Direction	To NW
N/A	X Walk 1 Width (in)	N/A	N/A	X Walk 2 Width (in)	N/A
	X Walk 1 Slope (%)	N/A		X Walk 2 Slope (%)	N/A
	X Walk 1 X Slope (%)	N/A		X Walk 2 X Slope (%)	N/A

N/A	Ramp inside XWalk1?	N/A	N/A	Ramp inside XWalk2?	N/A
	Road Slope (%)	4.9	N/A	Clear Space?	N/A
	Road X Slope (%)	2.3	N/A	Clear Space to XWalk (in)	N/A
N/A	Any Obstructions?	N/A	N/A	Storm Grate/Utility Hazard?	N/A
	Obstruction Type			Storm Grate/Utility Type	
		N/A			N/A
			Yes	Surface Condition? (G/P)	Good

**Remove & Replace Curb Ramp With Two New Directional Ramps or Equivalent.**
