Access Compliance Report

Public Rights-of-Way

(Curb Ramps)

Intersection ID: 13442	Main Street: MORRIS_FIELD_DR	Cross Street: AIRPORT_CENTER_PY	Location: SE
ADA ID: 9DC1E9F05A3E	Ramp Type: Perp	Initial Pass/Fail: Fail	Overall Compliance: No
Codes/Mitigation Info/Possible Solution		Field Measurements/Component Compliance	
Severity Score: 21.25

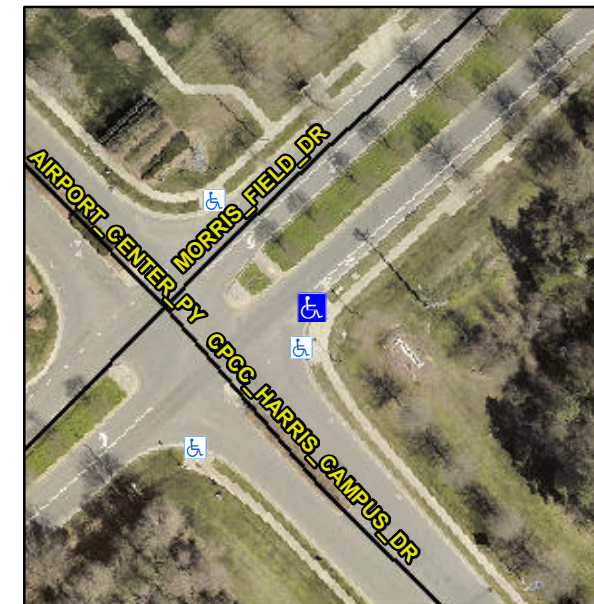
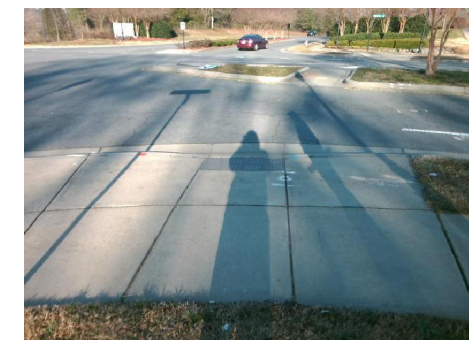
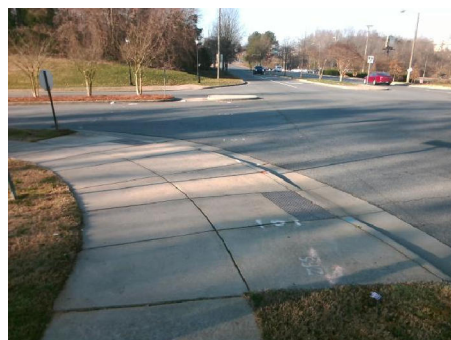
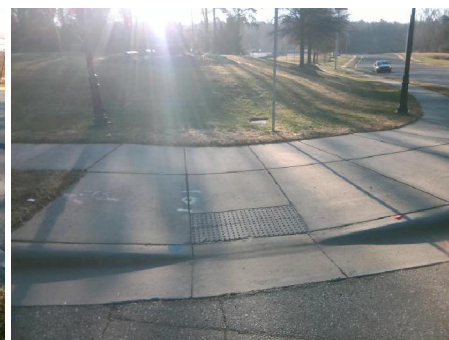
Not Found, R304.5.1, R304.5.3

Compliance	Description	Data	Compliance	Description	Data
N/A	Ramp Length (in)	72.0	Yes	Ramp Slope (%)	6.3
No	Ramp Width (in)	47.0	No	Ramp XSlope (%)	6.4
N/A	Flare Type LT	N/A	N/A	Flare Type RT	N/A
N/A	Flare Slope LT (%)	N/A	N/A	Flare Slope RT (%)	N/A
N/A	Flare Traversable LT?	N/A	N/A	Flare Traversable RT?	N/A
N/A	Landing Length (in)	N/A	N/A	DWS Provided?	N/A
N/A	Landing Width (in)	N/A	N/A	DWS Contrast?	N/A
N/A	Landing Slope (%)	N/A	N/A	DWS Length (in)	N/A
N/A	Landing X Slope (%)	N/A	N/A	DWS Full Width?	N/A
N/A	Landing Curb? (Y/N)	N/A	N/A	DWS Offset (in)	N/A
N/A	Shared Landing?	N/A			
N/A	Gutter Ponding?	N/A	N/A	Gutter Slope (%)	N/A
N/A	Gutter Lip Ht (in)	N/A	N/A	Gutter X Slope (%)	N/A
N/A	Painted X Walk1?	No	N/A	Painted X Walk2?	N/A
	X Walk 1 Direction	To NW		X Walk 2 Direction	N/A
N/A	X Walk 1 Width (in)	N/A	N/A	X Walk 2 Width (in)	N/A
	X Walk 1 Slope (%)	0.8		X Walk 2 Slope (%)	N/A
	X Walk 1 X Slope (%)	2.7		X Walk 2 X Slope (%)	N/A

N/A	Ramp inside XWalk1?	N/A	N/A	Ramp inside XWalk2?	N/A
	Road Slope (%)	N/A	N/A	Clear Space?	N/A
	Road X Slope (%)	N/A	N/A	Clear Space to XWalk (in)	N/A
N/A	Any Obstructions?	N/A	N/A	Storm Grate/Utility Hazard?	N/A
	Obstruction Type			Storm Grate/Utility Type	
		N/A			N/A
		Yes		Surface Condition? (G/P)	Good

Possible Solutions:

Remove & Replace Entire Ramp.
