Access Compliance Report Public Rights-of-Way (Curb Ramps)

Intersection ID: 53292 Main Street: PROSPERITY_RIDGE_RD Cross Street: I-485_RA Location: E

ADA ID: 9DCDD26BC4E2 Ramp Type: Perp Initial Pass/Fail: Fail Overall Compliance: No Severity Score: 13.75

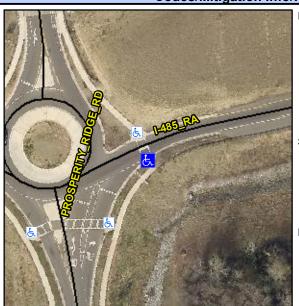
Field Measurements/Component Compilance							
Comp	Data	Compliance Description		Data			
N/A	Ramp Length (in)	92.5	No	Ramp Slope (%)	9.5		
Yes	Ramp Width (in)	48.0	Yes	Ramp XSlope (%)	2.3		
N/A	Flare Type LT	N/A	N/A	Flare Type RT	N/A		
N/A	Flare Slope LT (%)	N/A	N/A	Flare Slope RT (%)	N/A		
N/A	Flare Traversable LT?	N/A	N/A	Flare Traversable RT?	N/A		
N/A	Landing Length (in)	N/A	N/A	DWS Provided?	N/A		
N/A	Landing Width (in)	N/A	N/A	DWS Contrast?	N/A		
N/A	Landing Slope (%)	N/A	N/A	DWS Length (in)	N/A		
N/A	Landing X Slope (%)	N/A	N/A	DWS Full Width?	N/A		
N/A	Landing Curb? (Y/N)	N/A	N/A	DWS Offset (in)	N/A		
N/A	Shared Landing?	N/A					
N/A	Gutter Ponding?	N/A	N/A	Gutter Slope (%)	N/A		
N/A	Gutter Lip Ht (in)	N/A	N/A	Gutter X Slope (%)	N/A		
N/A	Painted X Walk1?	Yes	N/A	Painted X Walk2?	N/A		
	X Walk 1 Direction	To N		X Walk 2 Direction	N/A		
N/A	X Walk 1 Width (in)	104.0	N/A	X Walk 2 Width (in)	N/A		
	X Walk 1 Slope (%)	3.1		X Walk 2 Slope (%)	N/A

X Walk 1 X Slope (%)	4.4		X Walk 2 X Slope (%)	N/A		
N/A	Ramp inside XWalk1?	Yes	N/A	Ramp inside XWalk2?	N/A		
	Road Slope (%)	N/A	N/A	Clear Space?	N/A		
	Road X Slope (%)	N/A	N/A	Clear Space to XWalk (in)	N/A		
N/A	Any Obstructions?	N/A	N/A	Storm Grate/Utility Hazard?	N/A		
	Obstruction Type			Storm Grate/Utility Type			
		N/A			N/A		
			Yes	Surface Condition? (G/P)	Good

_	
200	Possible Solutions:
Sept.	Remove & Replace Entire Ramp.
ANG OF	
1	
1	
100	Surveyer Notes:
Sec.	Surveyor Notes:
N 100	N/A
Trans.	
9	PROW/ADA:
	R304.2.2
10	
Y

Total Cost: \$ 1850.00
